“ THE CONTRIBUTION OF INDIRECT TOPOGRAPHIC SURVEYS (PHOTOGRAMMETRY AND LASER SCANNER) AND GPR INVESTIGATIONS IN THE STUDY OF THE VULNERABILITY OF THE ABBEY OF SANTA MARIA A MARE, TREMITI ISLANDS (ITALY). ”

Marilena Cozzolino^{*,1}, Andrea Di Meo², Vincenzo Gentile²,

⁽¹⁾ Institute for Technologies Applied to Cultural Heritage, National Council of Researches, Via Salaria Km. 29,300, Monterotondo St. (Rome), Italia, ww.itabc.cnr.it

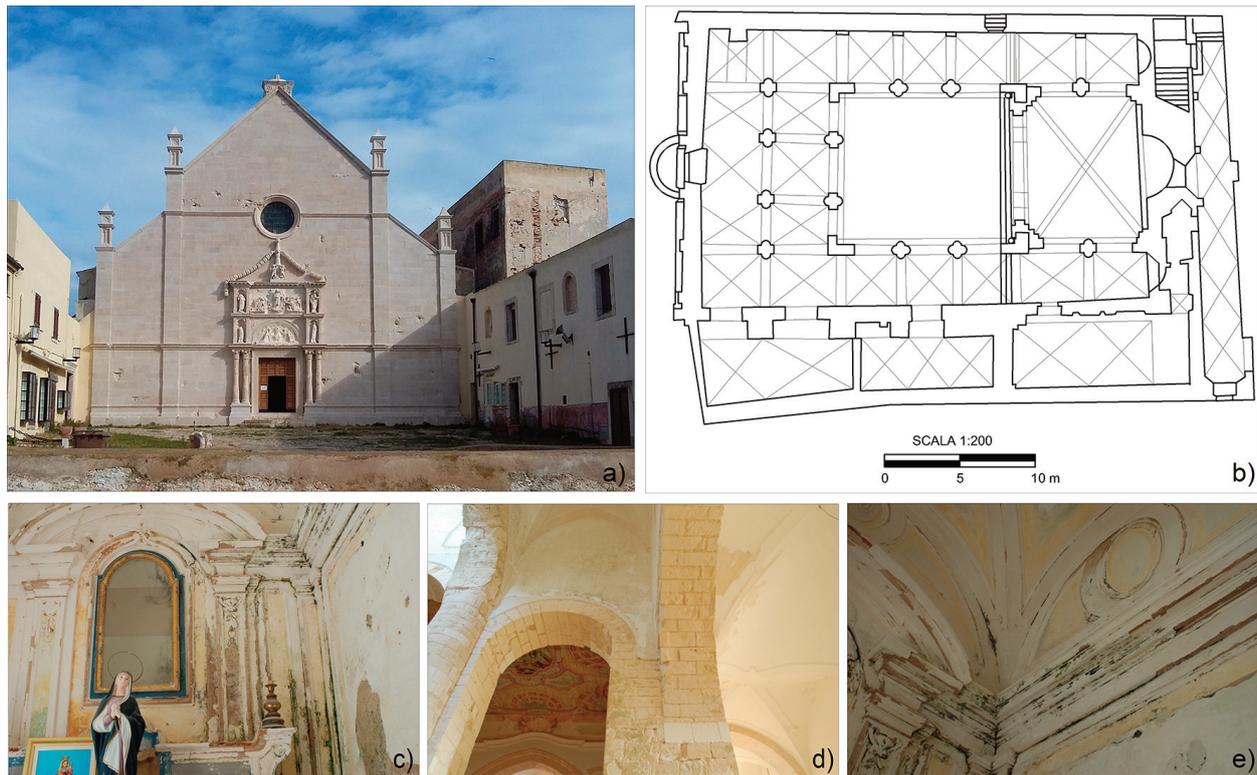
FIGURE 1. The Abbey of Santa Maria a Mare, San Nicola Island, Tremiti (Foggia, Italy): the facade (a), the plan (b) and some critical examples of degradation (c, d, e).

forms on which the sampling depends through the collection of significant samples to analyze in laboratory. In this work the results of 3D metric surveys and non-invasive geophysical investigations conducted at the Abbey of Santa Maria a Mare, located on the top of San Nicola Island in the Tremiti Archipelago (Foggia, Italy), are fully presented [Cozzolino et al. 2018a]. The Benedictines built it in 1045 AD and, even today, it preserves the original plant with a rectangular plan with three aisles that extend longitudinally from the entrance to the main altar (Figure 1a, b). The elaborate middle mosaic floor (XI-XII century) in polychrome tiles and the painted wooden ceiling made in the 18th century to replace the dome are particularly important. The monument is in a very poor state of conservation with evident signs of deterioration as substantial detachments of plaster, water infiltration, surface damage on the walls and column fractures. This condition is due to both structural problems and to pathologies related to the degradation of the materials making up the structure (Figure 1c, d, e).

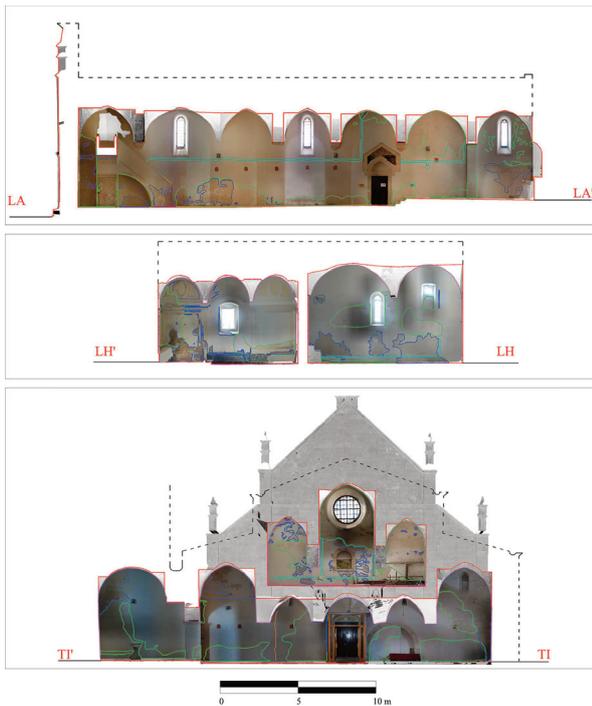
In Figure 5, the reflection section extrapolated from the 3D model with the application of orthophotos of the visible surfaces and the characterization of fractures,

FIGURE 5. LA-LA¹, LH-LH¹ and TI-TI¹ sections: reflection section extrapolated by the 3D model with application of the orthophotos of the visible surfaces and indication of anomalies (cutting plane in pink, detachments of plaster in dark blue, modern intervention in light blue, traces of humidity in green, fractures in orange, the section line in red)

traces of moisture, detachment of the surface, plaster and modern interventions on the foreground surfaces are reported for LA-LA¹, LH-LH¹ e TI-TI¹ sections.

The most critical conditions were found in sections near the outer walls (Sections: LA-LA¹, left side; LH-LH¹, right side; TI-TI¹, wall of the entrance) (Figure 5) where the phenomena of decay are more pronounced. The GPR surveys carried out on the inner wall of the entrance (ground floor and loggia) and on the left wall of the building confirm the presence of water within the analyzed surfaces. This is evidenced by the total absorption of electromagnetic signals found in radargrams and in the

Given the extent of degradation events, it can be assumed that water infiltration can be mainly due to the absorption and diffusion of rainwater through external surfaces constructed with non-water-repellent porous limestone blocks. Probable penetration through non-tightened openings and non-watertight or deteriorated covers should be added to these phenomena.

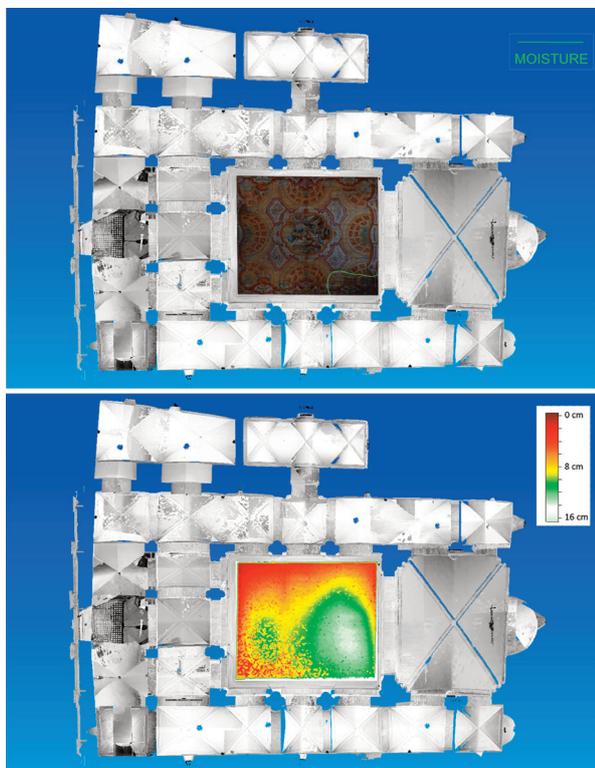
FIGURE 6. Orthophoto of the wooden ceiling located on a section of the 3D model with indication of anomalies (top) and model of elevation (bottom).

Figure 6 depicts an orthophoto of the painted ceiling, its characterization and a surface elevation model located on the section of the three-dimensional model.

As regards the wooden ceiling, some sections (LB-LB¹, LC-LC¹, LD-LD¹, LE-LE¹, LF-LF¹, TC-TC¹, TD-TD¹, TE-TE¹, T5-T5¹ and T6-T6¹) indicate a deviation from the horizontal axis between 0 and 0.16 m, concentrated above all on the left side. The digital elevation model extrapolated from the point cloud (Figure 6) shows variations in detected altitudes, differences partially coinciding with a visible moisture trace on the surface. For this anomaly, deform metric monitoring of active movements would be desirable in order to assess the evolution of the phenomenon.

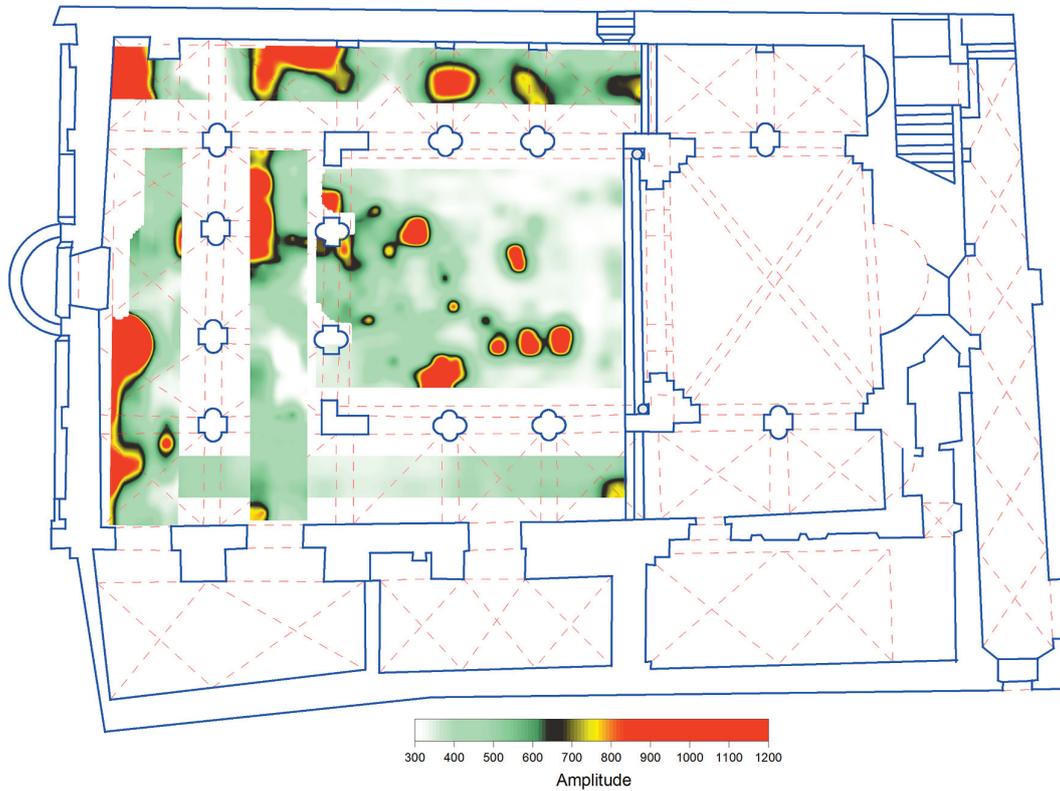
Five areas were investigated on the floor using a multi-frequency antenna (200-600 MHz). In total, 37 survey profiles were acquired for a total length of 445.7 m. Figure 7 shows the horizontal slices relative to 0.5 m in depth positioned on the floor plan of the building. Finally, using

FIGURE 7. Horizontal slice relative to 0.5 m in depth.

Finally, numerous irregularities and depressions emerged in the paved floor (especially near the mosaic), a slope from the left to the right side of the building (0.24–0.26 m) and from the central square to the entrance (0–0.09 m) (Sections L1-L1¹ and L2-L2¹). GPR analysis has not shown any anomaly that can be attributed to cavities or voids but only the presence of some elements that are probably attributable to structural elements prior to the present construction. In the central nave area, the bonding materials used in the restoration of the mosaic heavily disturbed the investigations.

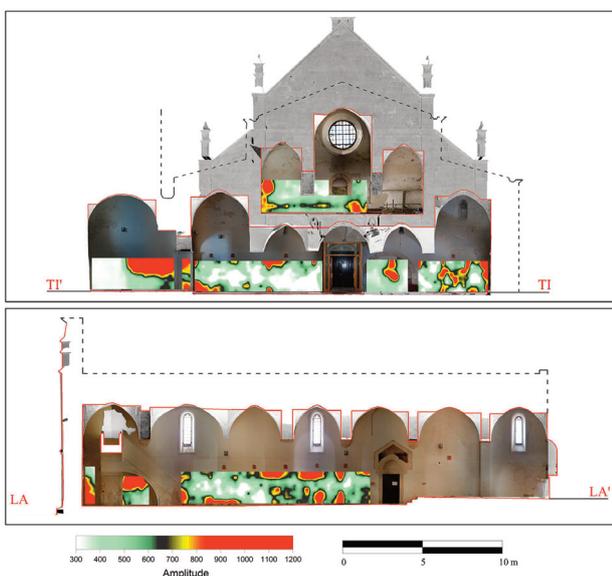
a 1200 MHz antenna, a high-resolution survey was carried out on the left wall of the building and on the inner wall of the entrance to verify the presence of moisture inside the masonry. Figure 8 reports the slice relative to 0.20 m in depth on LA-LA¹ and TI-TI¹ sections.

FIGURE 8. Vertical slice relative to 0.20 m in depth.

obtained parallel slice to the walls (Figure 8). In the latter, in the spots indicated by the green-white colors, low signal amplitudes were detected coinciding with obvious traces of moisture on the surface.

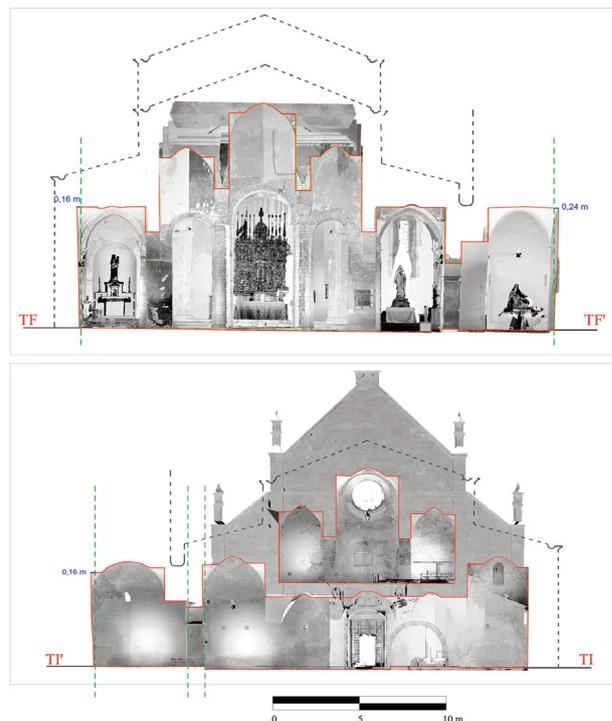
Finally, the laser scanner survey has enabled a precise geometric determination and an accurate morphological knowledge of the building. In detail, some elements that could be attributed to constructive defects and/or structural interventions carried out in recent times and/or to deformations caused by natural events (seismic movements and substrate settlements) may have emerged. Some sections (TB-TB¹, TC-TC¹, TF-TF¹, TG-TG¹, TH-TH¹ and TI-TI¹) show a non-verticality of the walls of the chapel located to the right of the church (deviation from the vertical axis between 0.1 and 0.24 m) and the outer wall of the left nave (deviation from the vertical axis between 0, 1 m and 0.16 m) (Figure 9). In particular, due to the presence of major fractures in the masonry of the rooms above the right aisle, such irregularities could favor, in case of seismic stresses, the right-tipping mechanisms of the right body.

FIGURE 9. Deviation from the vertical axis of the lateral walls (TF-TF¹ and TI-TI¹ sections).
