**The seismicity of Iran:  
The Torud earthquake of 12th february 1953**

N. N. AMBRASEYS (\*) - A. A. MOINFAR (\*\*)

SUMMARY. - The Torud earthquake of 12th February 1953 had a magnitude  $M_s$  of 6.4 and it occurred, after a long period of relative quiescence, on the synonymous fault zone in northern Iran, a desolate region on the borders of the Kavir. The shock was felt within a radius of 290 kilometres and it caused the death of about 800 people, mainly in the village of Torud. There is no conclusive evidence that the earthquake was associated with faulting. However, it did cause the liquefaction of saturated desert deposits.

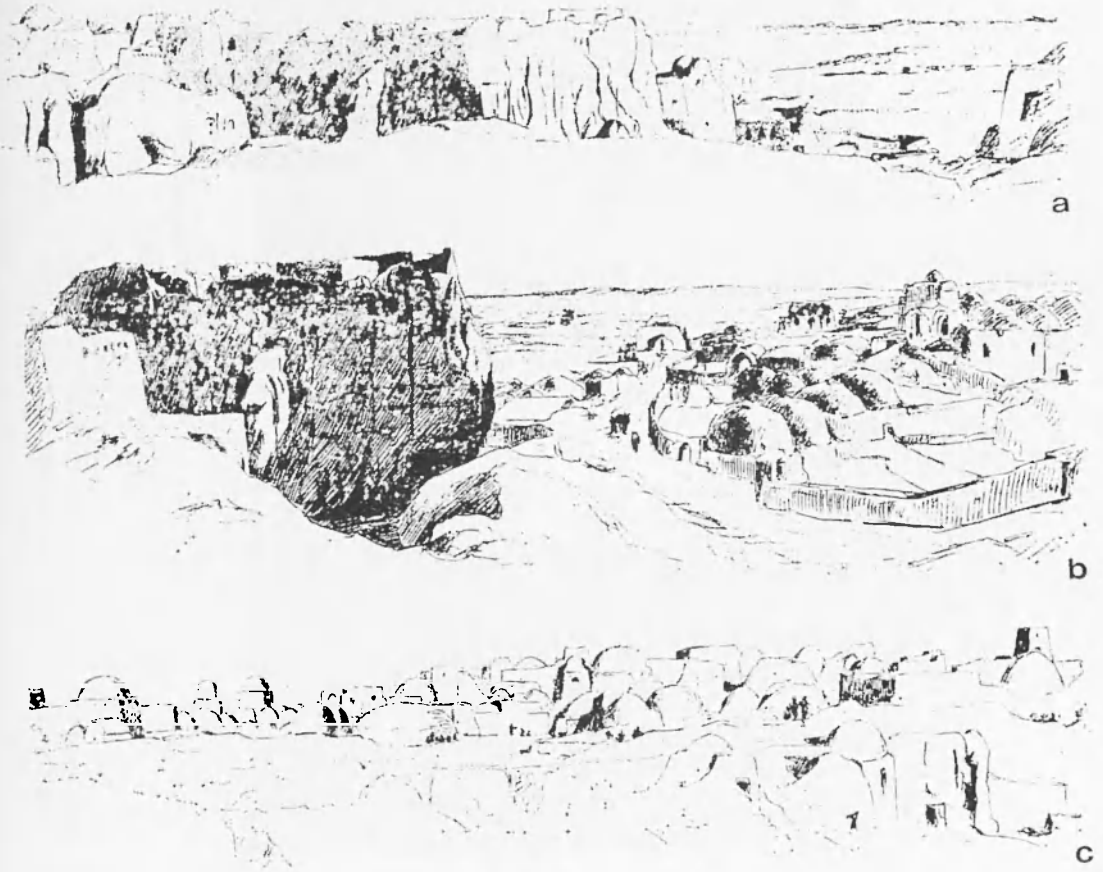
Fig. 2 — Sketches of Torud made by Sven Hedin in early February 1906. (a) looking south-west; compare with Plate I. (b) looking due south; notice terrace cliffs undercut by erosion. (c) looking north-east.

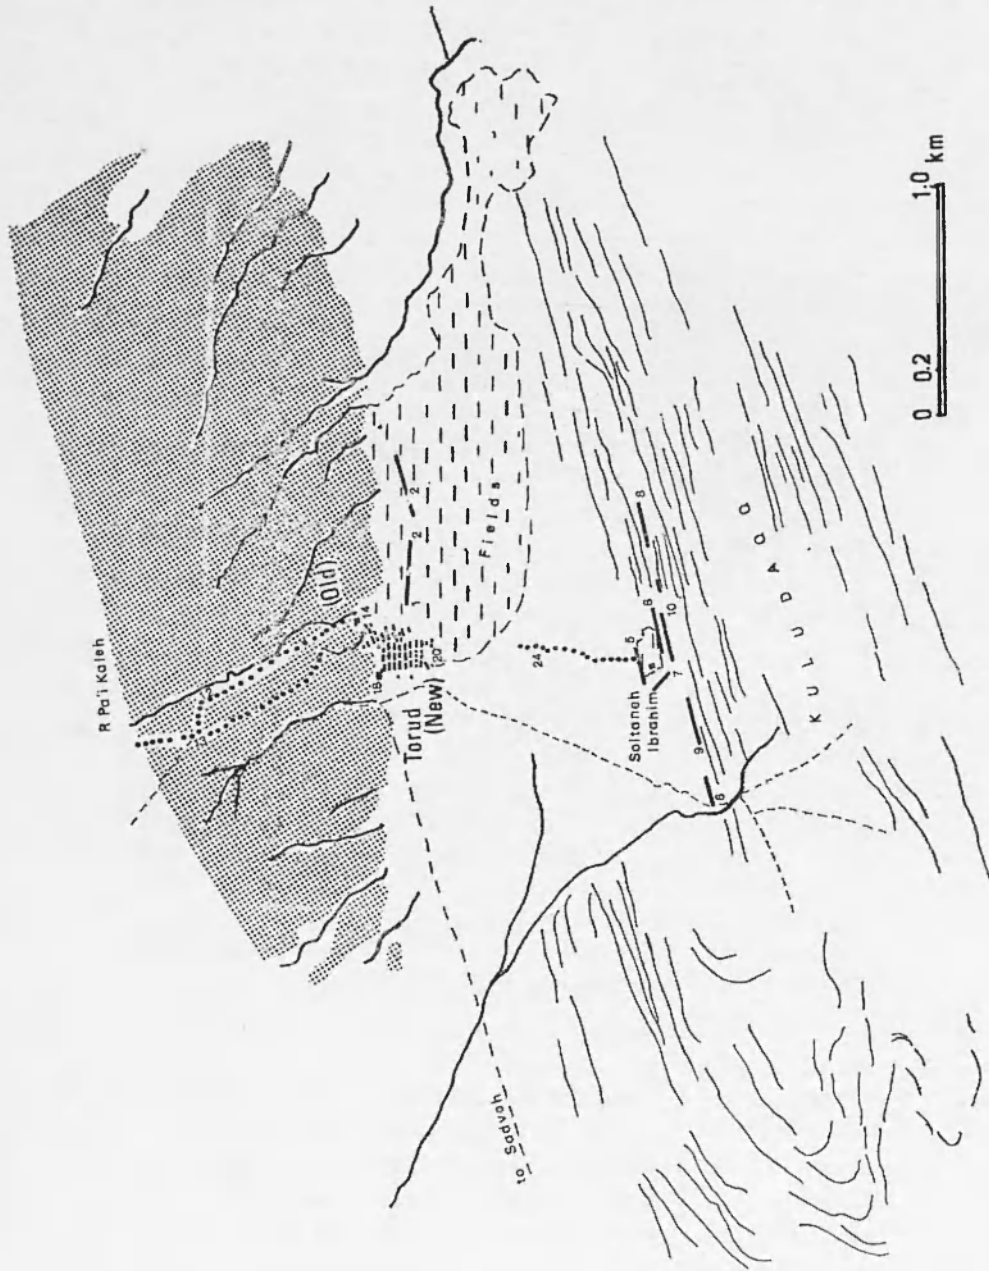
Fig. 3 — Map of the immediate vicinity of Torud showing location of ground deformations (No. 1, and 2 slumping of the ground below the qanat outlet No. 14; no. 5, 6, 7, 8, 9 and 10, shattered and in places eroded mudstones along bedding; no. 7, the only conjugate zone fractures in the form of shattered harder rocks. Compare with Plate 5.

obtained its water from the Rudkhaneh-pa'i Kaleh, a small river of seasonal flow with its source about 36 kilometres off to the north, that had cut deeply into the silts of the terrace, which stood on both sides into vertical walls 12 to 15 metres high, in places hollowed into caves by the running water. Some of these caves had been enlarged into temporary dwellings and storehouses and used by the villagers during the dry seasons. The only perennial supply of water for Torud was provided by an old qanat whose wells were sunk right through the silts, its stream emerging at the toe of the terrace, above which stood the dilapidated citadel of the village (<sup>4</sup>). By 1906 the village had grown and many of its new houses were built at the foot of the terrace, in front of which stood an Imamzadeh facing south. More caves had been excavated into the silts of the vertical walls of the Rudkhaneh for the storage of straw, firewood and for the housing of animals. In 1906 Torud had a population of not more than 1000 and about 250 proper houses. Fig. 2 shows views of Torud sketched in February 1906 (<sup>6, 7</sup>). By the mid-50's the size of the village had doubled and its population had risen to almost 2000 with 400 houses (<sup>4</sup>), and two smaller qanats were dug to supply water for irrigation (Figure 3, points 13 and 24). At the time of the 1955 earthquake, Torud had a population of about 2.100.

The earthquake completely destroyed Torud and only a few houses did not collapse. One of them is still there, located at the southwest limit of the new village (Fig. 3, point 20). Most of the casualties occurred in the old part of the village and in its narrow streets (Plates 1 and 2). No one was killed in the caves which stood up to the shaking far better than the ordinary houses of the village. Estimates of the casualties reported so far differ considerably, varying from 2000 to under 900 (<sup>2, 8, 10, 11</sup>).

The earthquake damaged the main qanat that today issues between the old and the new villages (Fig. 3, points 12, 14), as well as a much smaller qanat that runs to the south towards Dagg-Kulud. The former was soon repaired but its yield never rose above half of that yielded

At the time of the earthquake the underground water table in the fields that lie at the foot of the village, was only one to two metres below ground level, and it was almost at ground surface in the vicinity of the outlet of the main qanat (Fig. 3, point 14). In these fields, the shock caused the ground to slump and a series of long cracks to open up from

which brine and sand were ejected, particularly in the Paredasht farm where they were about 20 metres long (Fig. 3, points 1, 2). These are most probably the new cracks referred to by Gansser (<sup>5</sup>). Although the cracks are no longer visible except in two places, local information suggests that they were formed by the ground opening up within a narrow zone which runs discontinuously in an east-west direction for about 800 metres, from just south of the outlet of the Rudkhaneh-pa' i Kaleh to the east edge of the fields. Low adobe walls built after the earthquake across this zone today show no sign of subsequent displa-

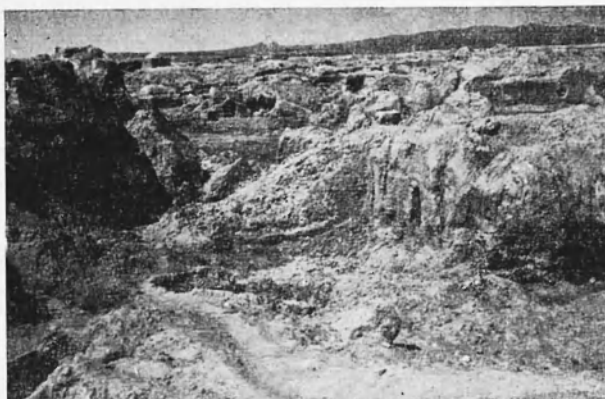
1 — Ruins of old Torud and caves in 1975: compare with Figures 2a and 2b.

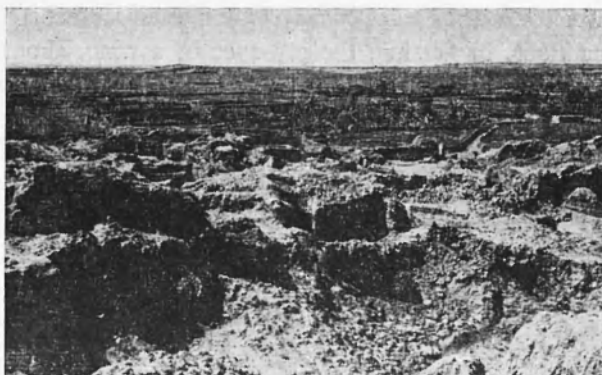
2 — Ruins of the upper part of old Torud, looking towards Daqq Soltaneh Ibrahim. New village, on the extreme right.

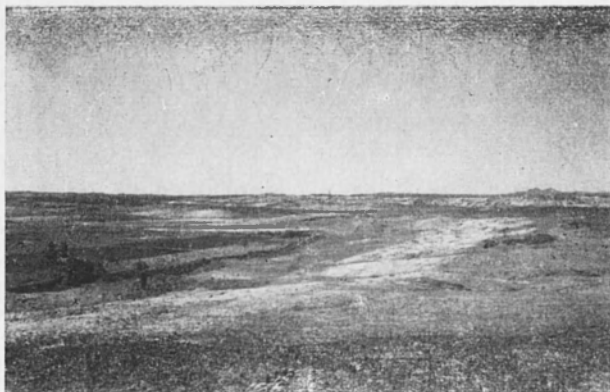
3 — View of area of ground fractures No. 6, 7 and 10 of Figure 3.

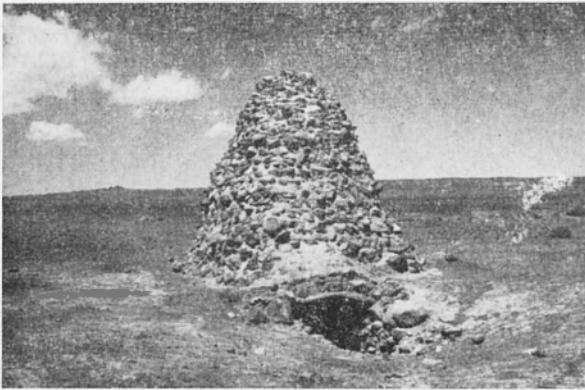
4 — The old Hauzi Paistan still standing.

Damage to isolated farmhouses and abandoned settlements in the area was found to be difficult to assess. About 7 kilometres southwest of Torud, Hauzi Paistan, an ab-ambar or water reservoir covered with a dome of stone masonry was not damaged (Plate 4). About 18 kilometres from Torud in the same direction, Chah Ala'-e Pain, a farmhouse, was damaged. Two other farmhouses, uninhabited at the time of the earthquake and located in the hills between Chah and the site of the Imamzadeh Pir Mardan (or Nur 'Ala'), collapsed completely and a spring of water dried up. At 26 kilometres from Torud on the road to Satveh, near the disused ab-Ambar of Sangi-i Sur, the shock caused another spring of brackish water to dry up. At this place, a few hundred metres northwest of the main road, the earthquake caused some slumping of the ground. According to local information this should have occurred where
