# Re-evaluation of the macroseismic effects produced by the March 4, 1977, strong Vrancea earthquake in Romanian territory

Aurelian Pantea, Angela Petruta Constantin\*

*National Institute for Earth Physics (NIEP), Bucharest-Magurele, Romania***Article history**

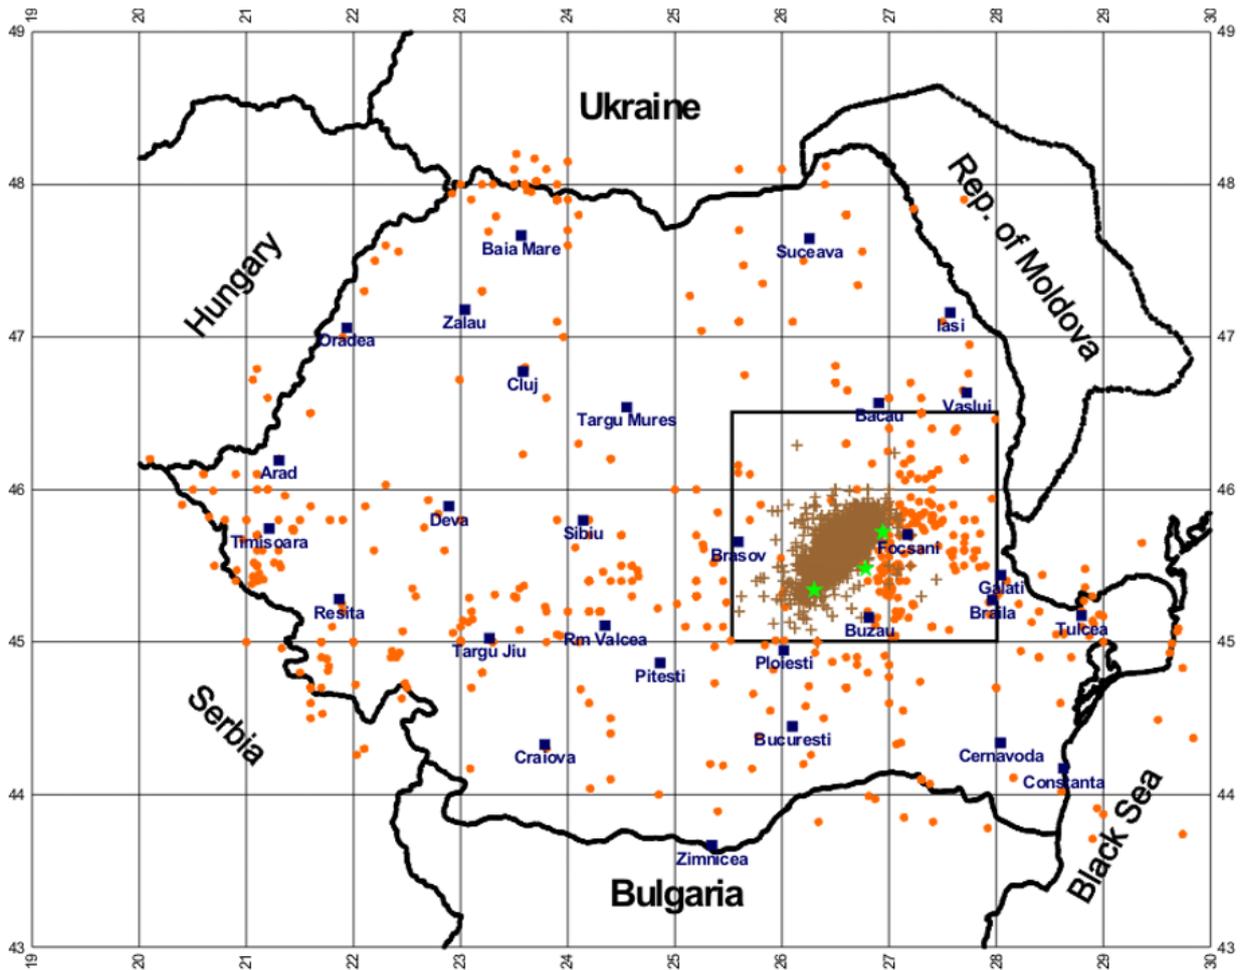
**Figure 1** (above). Seismicity of Romania from 1984 to 2011, for  $M_W \geq 3$ . Brown crosses, subcrustal earthquakes; orange dots, crustal earthquakes [from Romplus catalog 2011].

types of earthquakes occur: intracrustal earthquakes (less than 60-70 km deep), and subcrustal earthquakes (between 70 and 200 km deep). The seismicity of Romania from 1984 to 2011 for shocks with magnitude  $M_W \geq 3$  is shown in Figure 1 [Romplus catalog 2011]. The distribution of the epicenters for the Vrancea earthquakes from the same period is shown in Figure 2. The earthquakes that have occurred in the Vrancea seismic zone are responsible for 90% of the seismic activity in Romania, thus releasing more than 95% of the total seismic energy. Therefore, the seismicity of the Romanian territory and its specific pattern is strongly determined by the Vrancea seismogenic zone. This region is characterized by strong subcrustal earthquakes ( $M_W > 7.0$ ), the frequency of occurrence of which is low (4-5 destructive earthquakes per century). The crustal seismicity of this region is characterized by moderate earthquakes with magnitudes that have not exceeded  $M_W 5.9$ , with this value being assigned to an earthquake that occurred in historical times on March 1, 1894 [Oncescu et al. 2000, Romplus catalog 2011]. The last earthquake that occurred in this region was the October 27, 2004, subcrustal earthquake [Romplus catalog 2011], which was the only significant event over the last two decades, both in terms of magnitude ( $M_W 6$ ) and observed macroseismic effects.

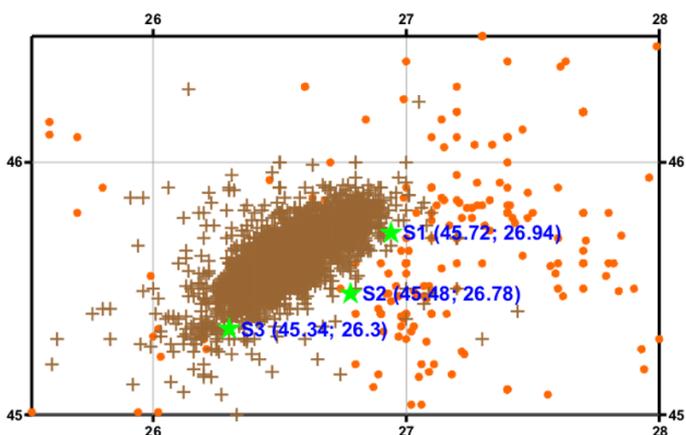
**Figure 2** (below). Seismicity of the Vrancea zone. The stars correspond to the epicenters of the three shocks of 1977. The area corresponds to that indicated in Figure 1.

depth, 109 km) (Figure 2), thus emphasizing that the rupture focus propagated to the SSW [Müller et al. 1978].

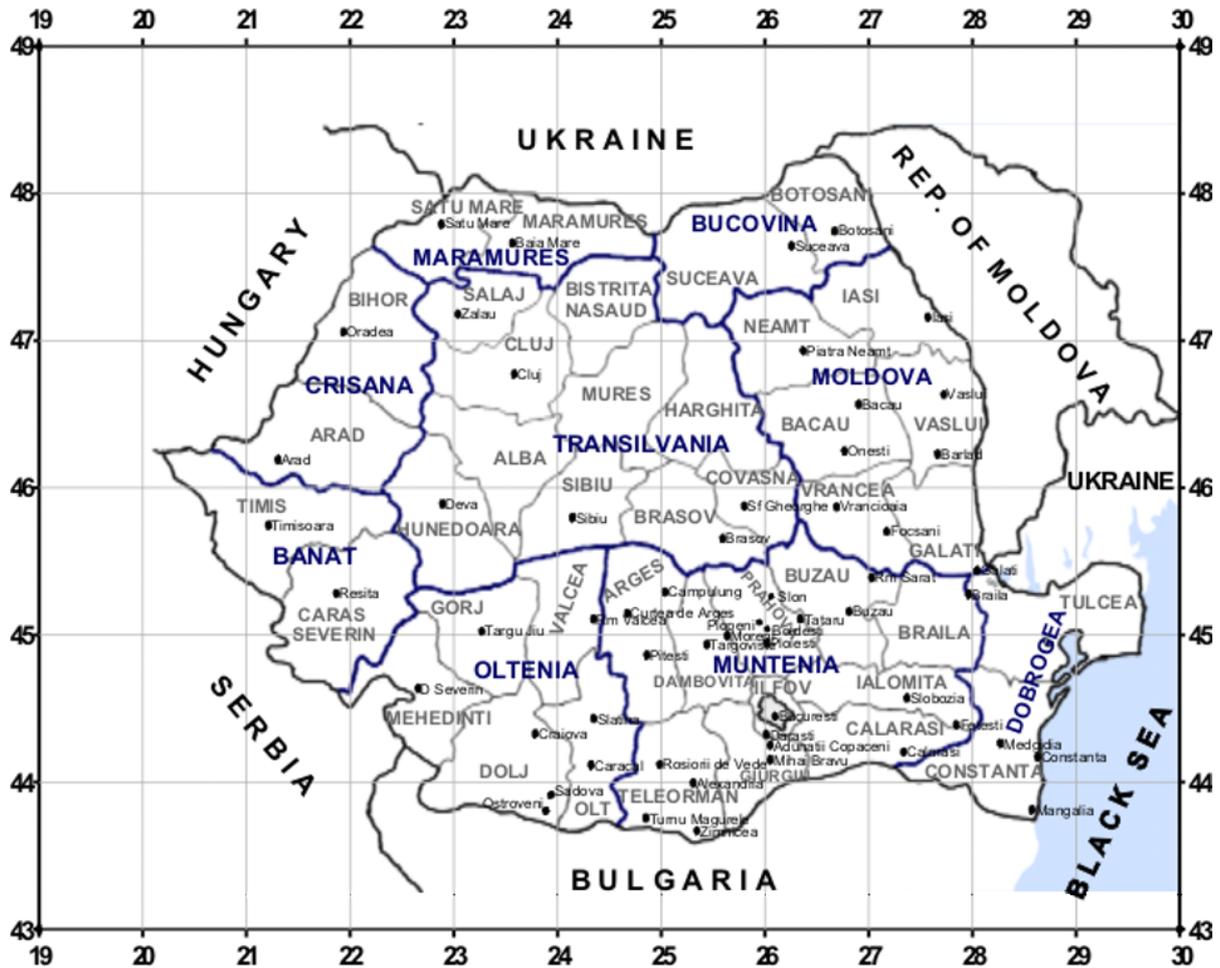
Figure 3. Romanian regions: counties and places mentioned in the text and in Table 1.

the earthquake, more than 12,000 macroseismic questionnaires were distributed in areas throughout the country, and especially in the damaged areas of Oltenia, Muntenia and Moldova (see Figure 3), among others, to obtain a more complete and unitary image of the macroseismic effects. The macroseismic questionnaires were distributed to the local/public authorities, and directed to the population. They needed to be filled in and then sent to the Centre for Earth Physics and Seismology (now the National Institute for Earth Physics, Bucharest-Magurele, Romania). The macroseismic questionnaire used for this earthquake contained a number of questions related to construction types, nature and degree of damage, effects on the surroundings, and human and animal reactions. The first part of this macroseismic questionnaire included the administrative data (e.g., locality, owner, street), the types of buildings (i.e., A, B, C structures), and the classification of the damage to buildings (all 5 grades), according to the MSK-64 macroseismic scale [Medvedev et al. 1967]. Each observer thus had the possibility to select the type of building and the level of damage caused by the earthquake to the building in question. The other questions were related to effects felt by the people, and the effects on objects and on the environment, as 54 questions, and they covered

The distribution of the re-evaluated macroseismic intensities observed for the Romanian territory is shown in Figure 7. Table 1 gives the re-evaluated macroseismic intensities for some of the most important cities in Romania, together with the total number of macroseismic questionnaires that were available for each city, and the epicentral distances. All of the cities in Table 1 are shown in Figure 3.

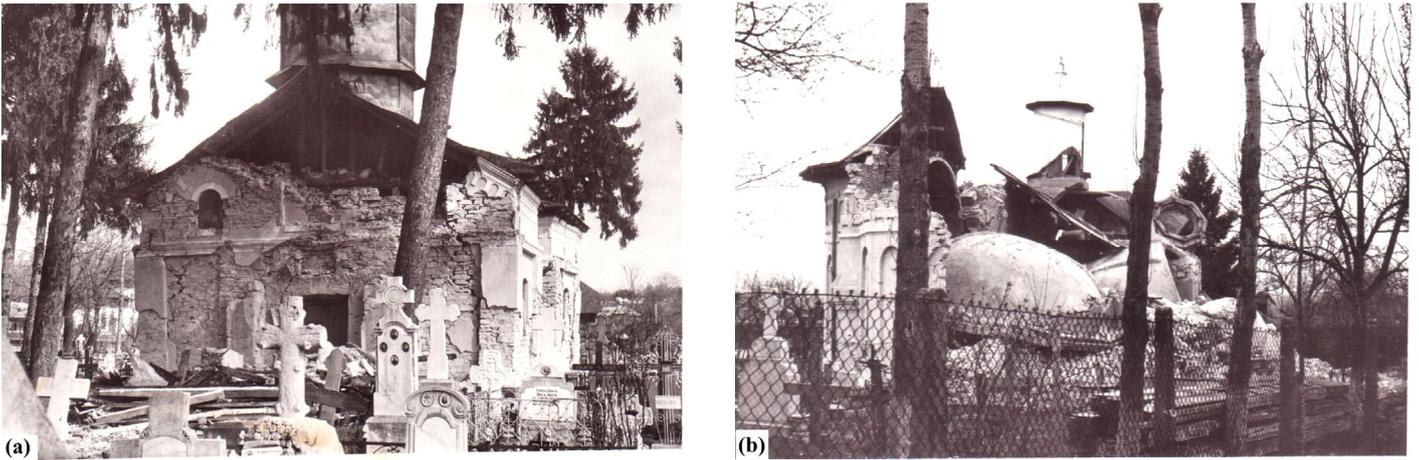
**Figure 4.** Masonry buildings destroyed in Prahova county. (a) Partial collapse of a church in Drajna (subsequently demolished). (b) Total collapse of a church in Boldesti (photos by Pantea [1979]).

Many churches in the areas visited were heavily affected, with wide and deep cracks in walls, and partial or total collapse (see Figure 4). Some industrial constructions, hospitals and schools in the towns in these counties were seriously damaged as a result of the earthquake.

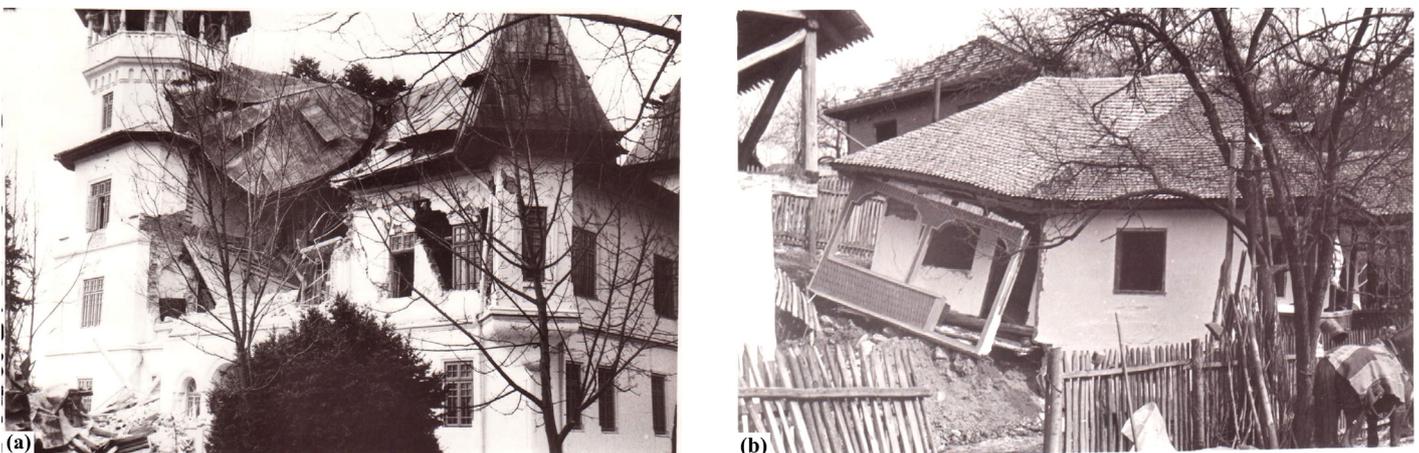
**Figure 5.** Partial collapse of a masonry building at Drajna (a) and heavy damage to a wooden house at Slon (b), in Prahova county (photos by Pantea [1979]).

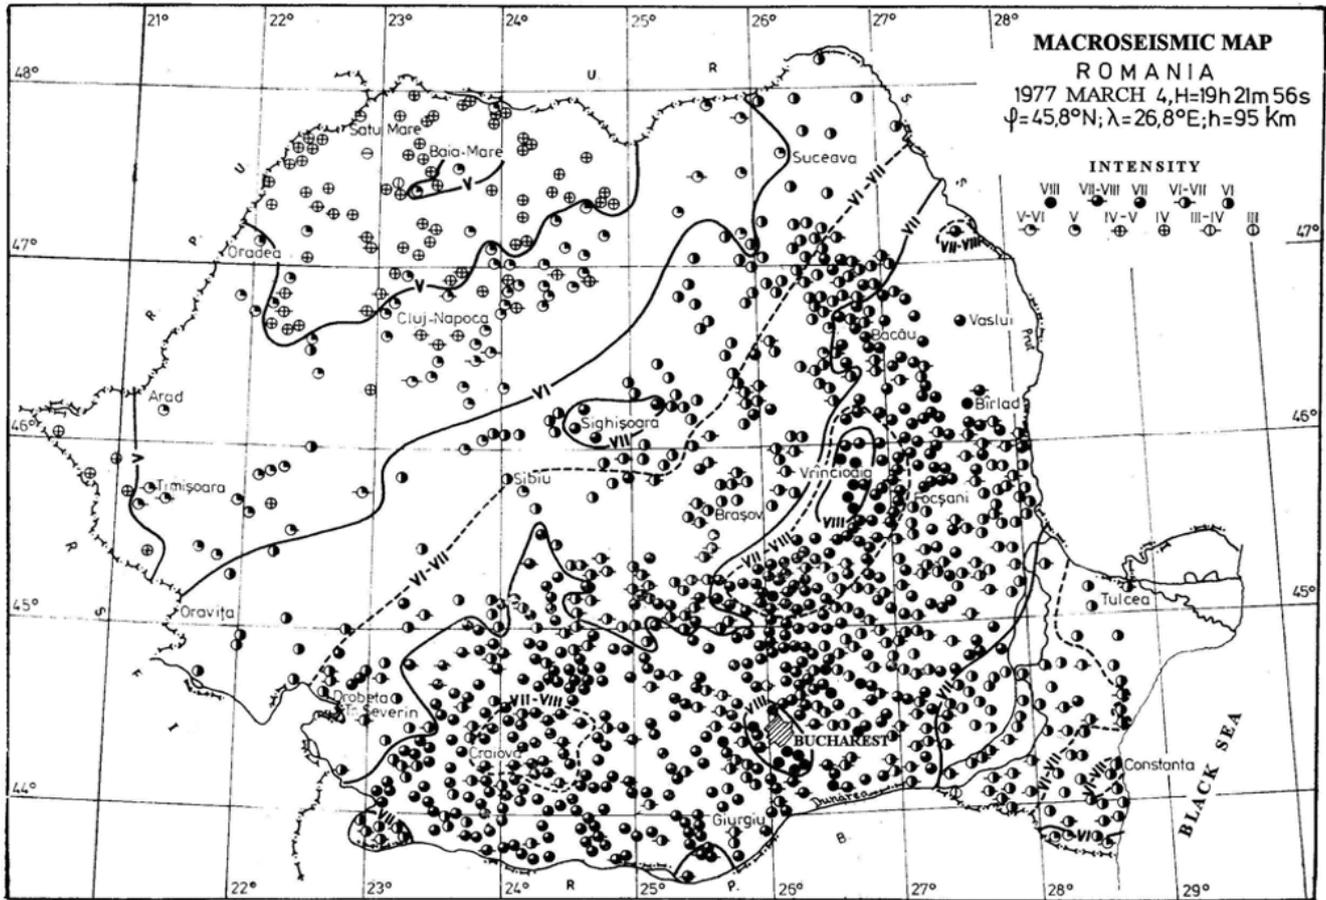
Figure 6. Macroseismic map for the March 4, 1977, Vrancea earthquake, as drawn up by Radu et al. [1979a].

The re-evaluated macroseismic map shows for some sites values of seismic intensity that are higher by half to one and a half degrees, compared to those obtained by Radu et al. [1979a] (Figure 6).

In the macroseismic map of the March 4, 1977, earthquake drawn up by Radu et al. [1979a], the seismic intensity in the epicentral area showed an  $I_0$  of VIII MSK; after the re-evaluation of the macroseismic effects observed in this area, it was concluded that the epicentral intensity was an  $I_0$  of IX MSK. Moreover, by comparing the two maps, as the map formerly published and the map from our recent re-evaluation, it can be seen that the areas corresponding to intensity VII and VIII MSK are more extended than those defined in the map drawn by Radu et al. [1979a]; furthermore, in the former map, there were no areas with an intensity of IX MSK.

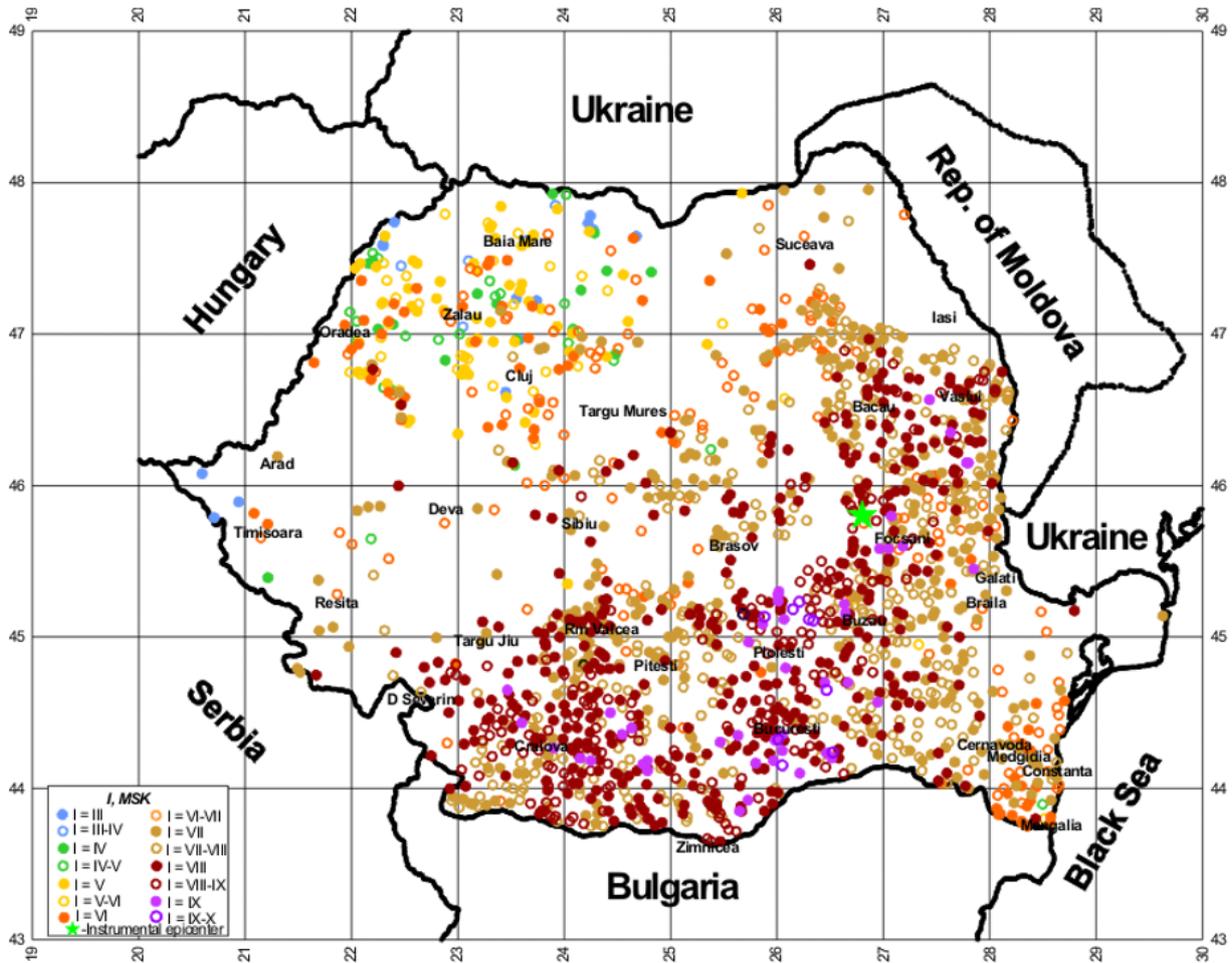
Figure 7. Re-evaluated macroseismic map of the March 4, 1977, subcrustal earthquake.

As can be seen in the re-evaluated macroseismic map (Figure 7), and on the basis of the maximum effects in Bulgarian territory corresponding to VIII MSK [Grigorova et al. 1977], the intensity attenuation was relatively weak in the southwest direction from the epicenter, as had been seen for some previous subcrustal earthquakes with foci in the same area (e.g., the October 26, 1802, earthquake). Thus, the new intensity data-point map presented in Figure 7 accurately reproduces the two main features of the earthquake: the affected area as more extended, and the weak southwestern attenuation. These features were also emphasized in the macroseismic map drawn up by Radu et al. [1979a], but as mentioned above, the values given to the intensities were lower.

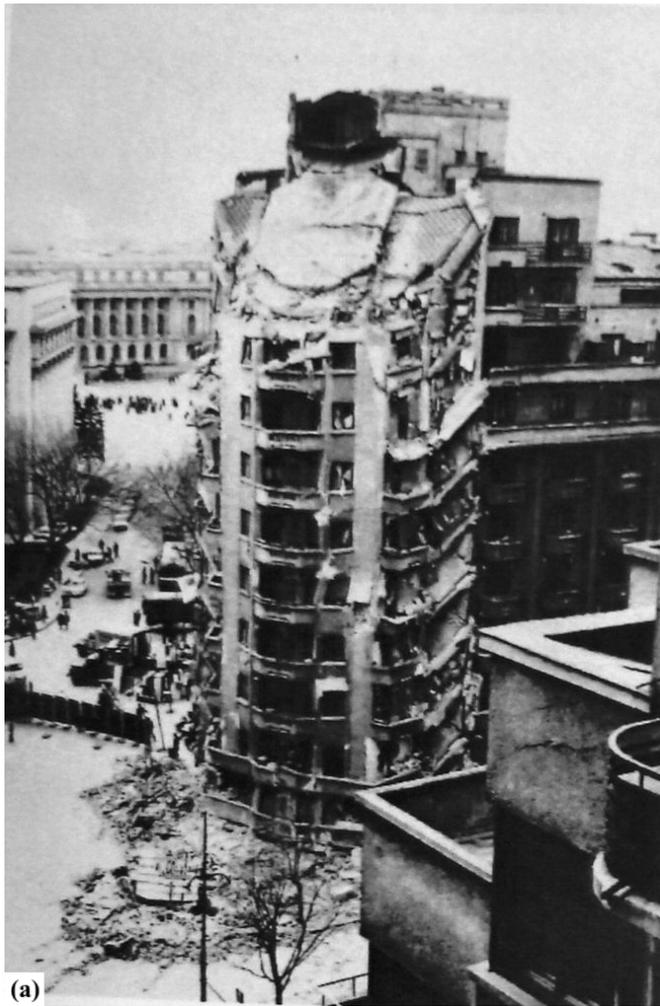
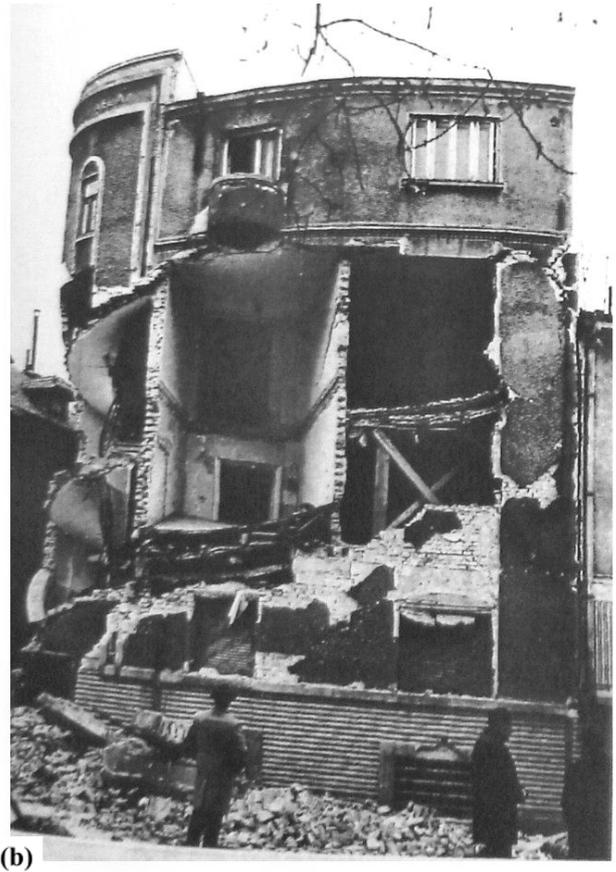
**Figure 8.** Partial collapse of buildings. (a) The Wilson building (reinforced concrete frame building with masonry infill walls). (b) A masonry building. (photos by Hirosawa [2007]).

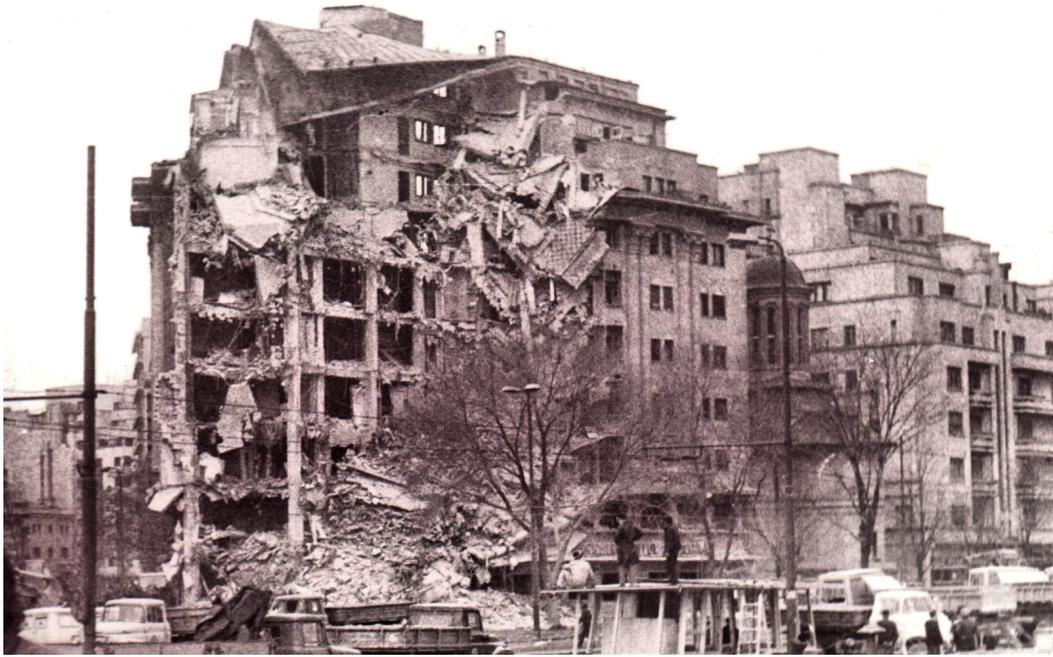
**Figure 9.** Partial collapse of the 'Dunarea' building (reinforced concrete frame building with masonry infill walls) (photo by Ene [1977]).
