“ SEISMIC ASSESSMENT OF THE MEDIEVAL ARMENIAN CHURCH IN FAMAGUSTA, CYPRUS ”

Andrés Burgos Braga^{*,1}, Paulo B. Lourenço¹, Nuno Mendes¹

⁽¹⁾ Dept. of Civil Engineering, ISISE, University of Minho, Guimarães, Portugal

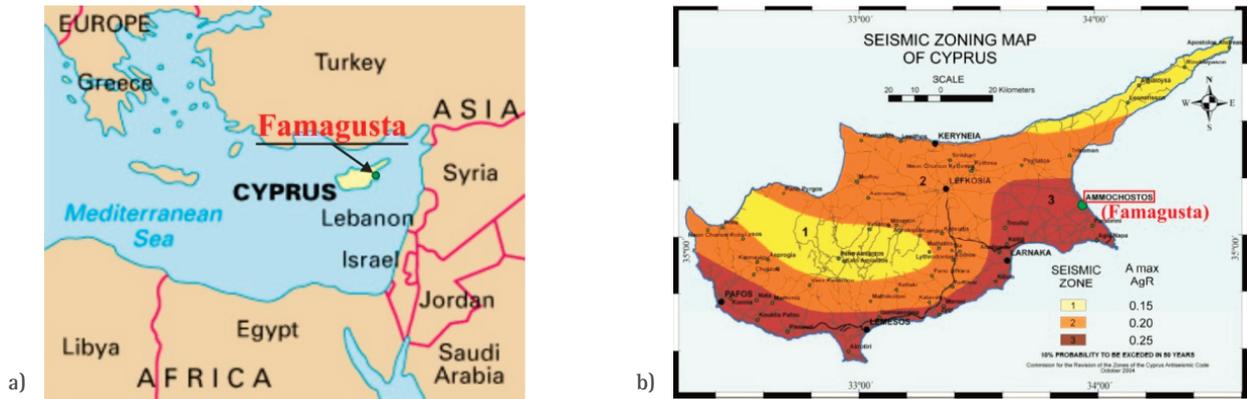
FIGURE 1. Cyprus and the city of Famagusta. (a) Location of Famagusta; and (b) Seismic Hazard Map of Cyprus [CYS EN 1998–1:2004, 2010] (Return period: 475 years).

The walled city of Famagusta, located in the north-eastern part of Cyprus (Figure 1a), was once one of the richest cities in the world thanks to its key location on the Eastern Mediterranean. Nonetheless, a long succession of invasions and several cycles of destruction and reconstruction of the city, led Famagusta to its inevitable decline. Today, the Cypriot port is politically within the self-proclaimed Turkish Republic of Northern Cyprus and is an embargoed and internationally isolated region, threatened by earthquakes, abandonment and neglect. Due to the severe state of deterioration of its vast architectural richness, the port city was placed on the 2008 World Monuments Watch List of 100 Most Endangered Sites by the World Monument Fund [World Monuments Watch, 2008].

likely to increase the hazard. A soil factor S equal to 1.35 (type “D”) is recommended, leading to a PGA of 0.34 g [Safkan, 2012].

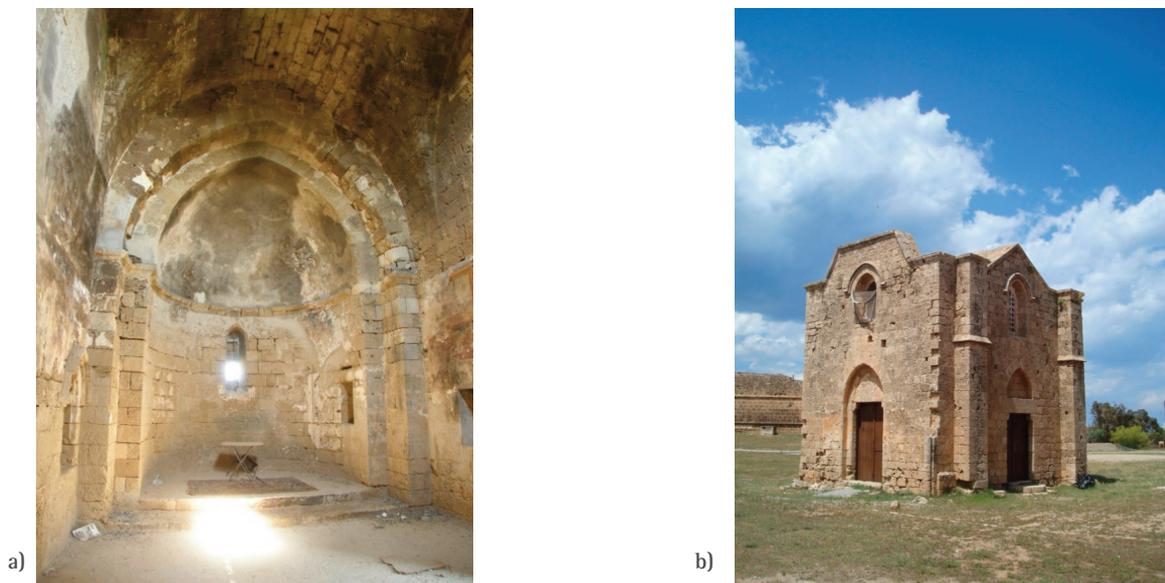
FIGURE 2. Interior and exterior features of the Armenian Church. (a) East-end of the Church viewed from the interior; and (b) the Church exterior view from the southwest.

The Church is made of limestone ashlar masonry and is architecturally simple. The interior consists of a one-bay rectangular nave that ends at the east with a double-arch leading to a semicircular, pointed semi-domed apse (Figure 2a). The nave is covered by a groined vault of stone, with short barrel vaults to east and west. Doors are present on the west, south and north walls (the latter presently closed with brick masonry), and single windows are found on each side of the building. Moreover, the interior of the Church is decorated with three niches as well as with remnants of fresco paintings that, currently, are in an advanced state of deterioration. Many of the frescoes have been whitewashed over, with only the upper registers still visible [Langdale et al., 2009].

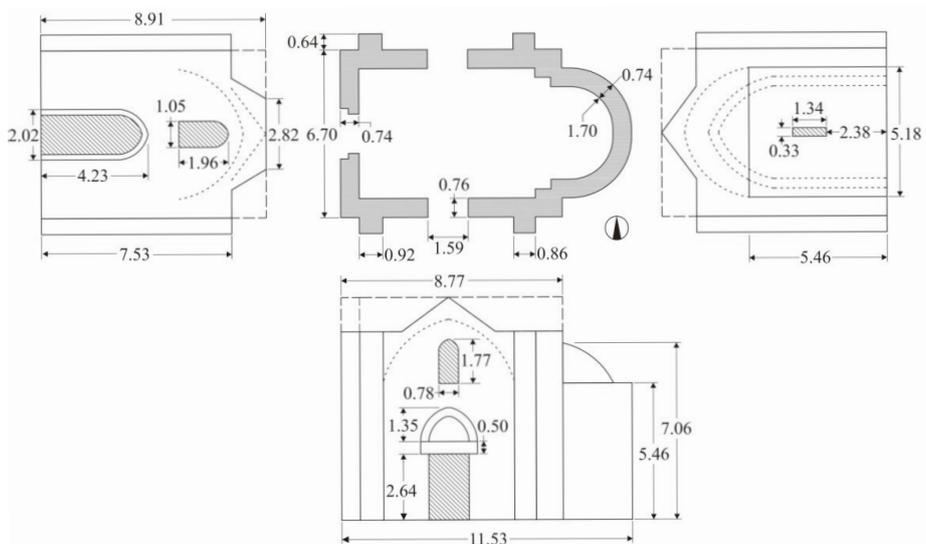
FIGURE 3. Geometry of the Armenian Church. Units: m.

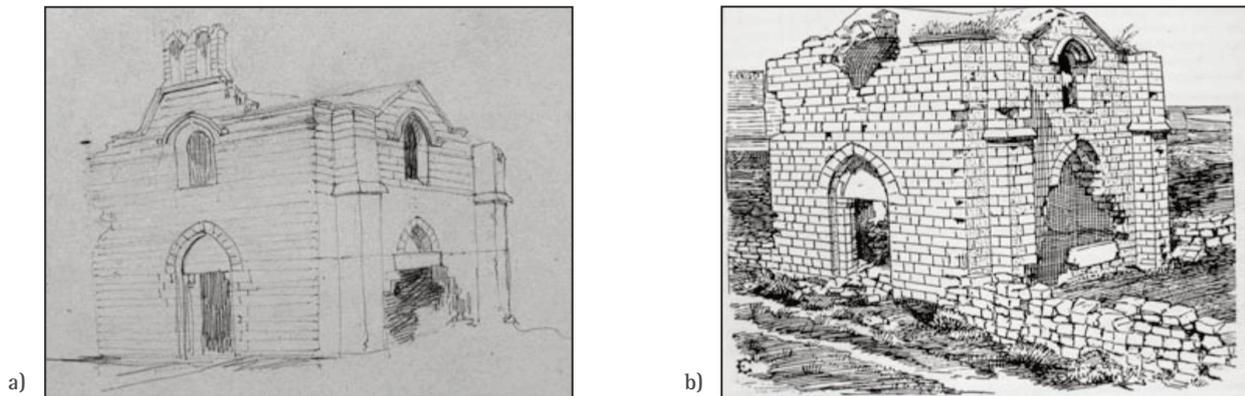
FIGURE 4. The Church on the 19th century. (a) Drawing by E. Duthoit, pencil on paper, 1862 (Museum of Picardie, Amiens); and (b) drawing by C. Enlart, 1896 from [Enlart, 1899].

The Church might have notably deteriorated from mid- to late 19th century. Figure 4a presents a drawing of the Armenian Church, made in 1862, where it shows

a general good condition except for some blocks that had fallen away from around the south portal and some visible loss of material on the northwest and southeast top corners. The same drawing also shows the still surviving belfry at the top of the west gable. In comparison, Figure 4b presents another drawing of the Church, made in 1896, from the same angle. Here, the failure of the south portal is visible and the partial ruin of the vaulting at the western and southern tips of the gables is suggested. The bell tower is lost as well as part of the west window; and the loss of material seems to have notably increased. No strong earthquake seems to have been reported within this period.

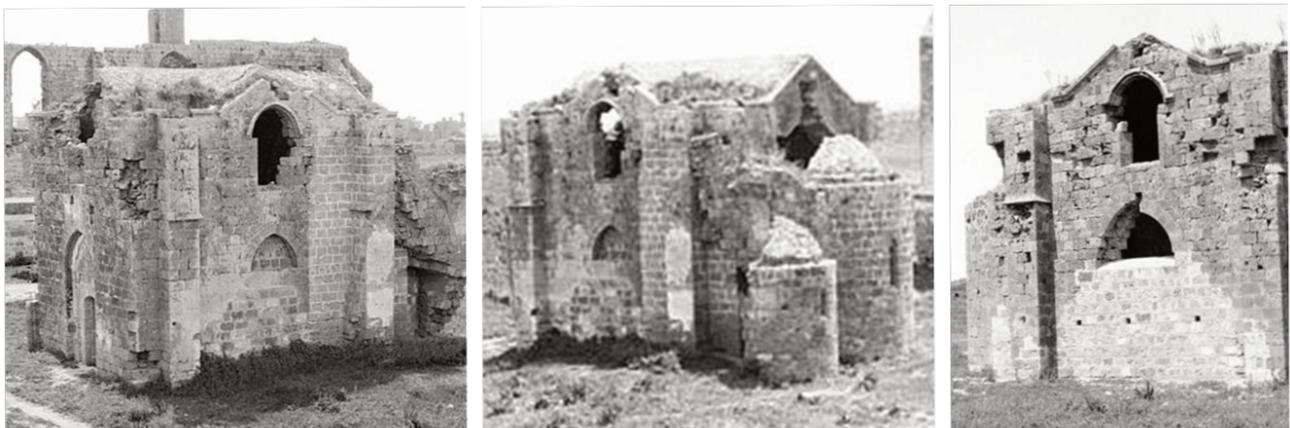
FIGURE 5. The Church in 1911 (Médiathèque de l'architecture et du patrimoine, France).

In 1878, the British took control of the port city and started restoration works in various Famagusta's monuments, including the Armenian Church. Figure 5 shows the state of the building in 1911, after some stabilization works, which can be distinguished by the light-colored stone. Note that the gable of the west façade has fallen and damage has affected part of the dome and east wall. Also, the partial collapse of the masonry around the north entrance, including the lintel, is suggested. Moreover, these pictures show part of a small sacristy that used to be attached to the apse but is now no longer existent.

Figure 18, with respect to the old and current real condition of the Armenian Church (Figure 5, 7 and 8), various damage features of the building can be justified and attributed to seismic actions. In particular, good accuracy of the damage location was obtained on the west and east sides of the building, namely the simulation of the current cracks around the west window and above the dome, as well as the damage at the top of the internal double-arch that leads to the apse. Likewise, the past failure of the dome and of the section above, and the collapse of the west gable, can also be observed.

The cracks around the west window are also consistent with the information provided by the Damage Abacus [NIKER, 2010], which is an inventory that compiles typical seismic failure mechanisms of cultural heritage. According to this inventory, this crack pattern, commonly found in churches, can lead to an in-plane shear failure mechanism of the masonry structure causing either the failure of the whole façade or the localized failure of the top section of the window, as shown in Figure 23, a and b, respectively. In this case, the localized failure of the top of window can be related to the historical damage of the Church observed in Figure 5.

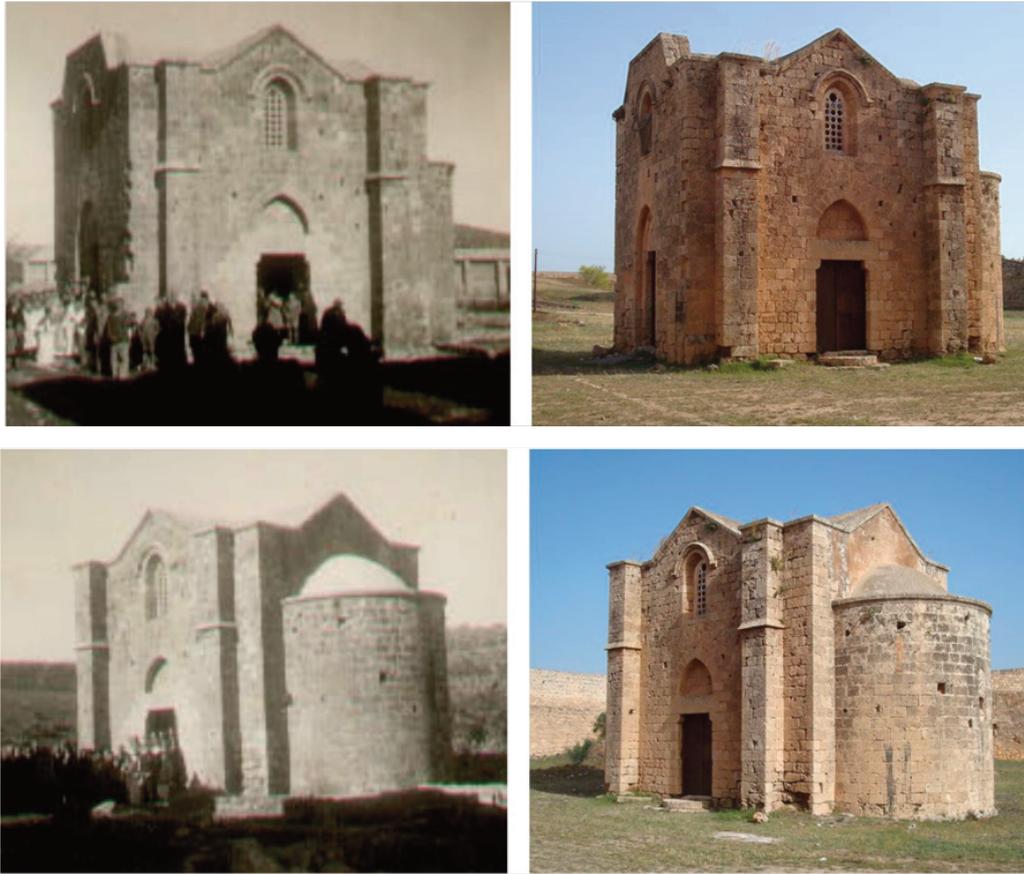
FIGURE 6. Visual comparison of the state of the Church: 1945 situation vs. present condition (Historical pictures from the Mogabgab Archive, Famagusta).

From 1945 to nowadays, the condition of the building seems not to differ much as shown in Figure 6. The exterior of the Church is today characterized by (Figure 7): (a) cracks between openings and above the dome; (b) stone deterioration mostly at bottom sections, probably due to splashing rain and rising damp; (c) loose stone units that need to be consolidated; (d) biological activity, namely vegetation at base and roof level; (e) windows without proper protection against environmental elements; (f) inefficient buttressing due to material loss; (g) deteriorated mortar joints in various areas; and (h) presence of cavities in the walls, some of which are not original and need to be filled in. Regarding the roof and dome, due to the presence of plaster, no important cracks are visible; only vegetation and lichens are present.

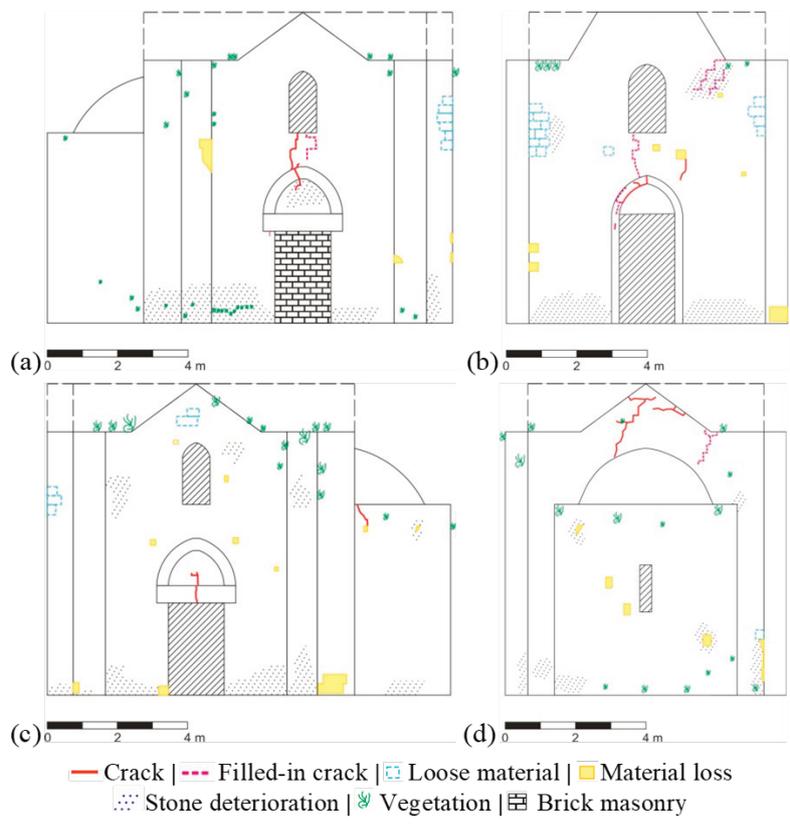
FIGURE 7. External damage maps of the: (a) north, (b) west, (c) south and (d) east sides of the Armenian Church.

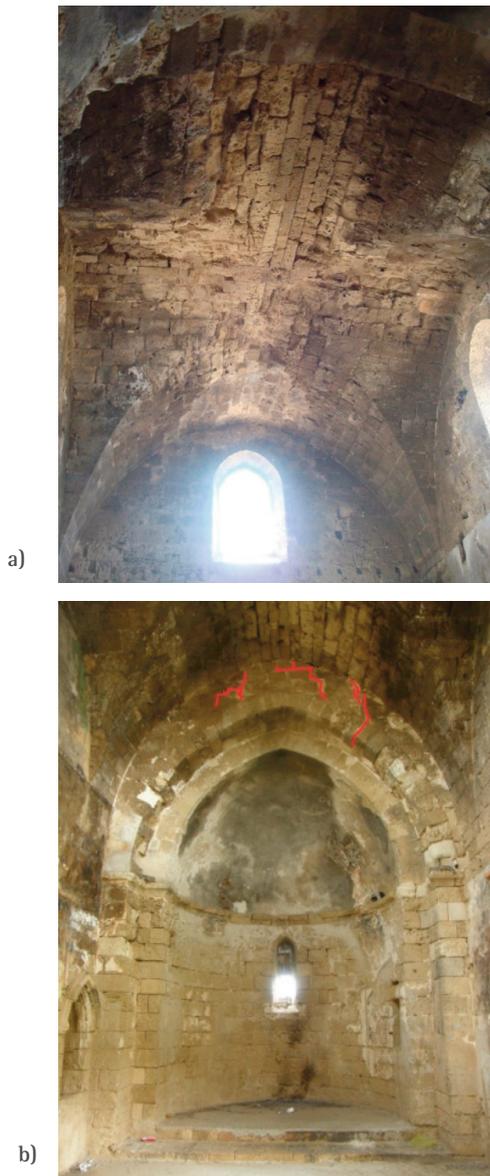
FIGURE 8. Deteriorated state of (a) the vaulted roof and of (b) the internal double-arch (with highlighted cracks at the top).

In particular, the vault is in bad condition, which can be caused by the inefficient protection against water infiltration (Figure 8a). Moreover, similar to the external cracks, the internal cracks are mainly located between openings at the north, south and west walls; and also at the top of the double-arch that leads to the apse (Figure 8b). Other cracks may also be hidden under the plaster that covers most of the bottom-half section of the walls.

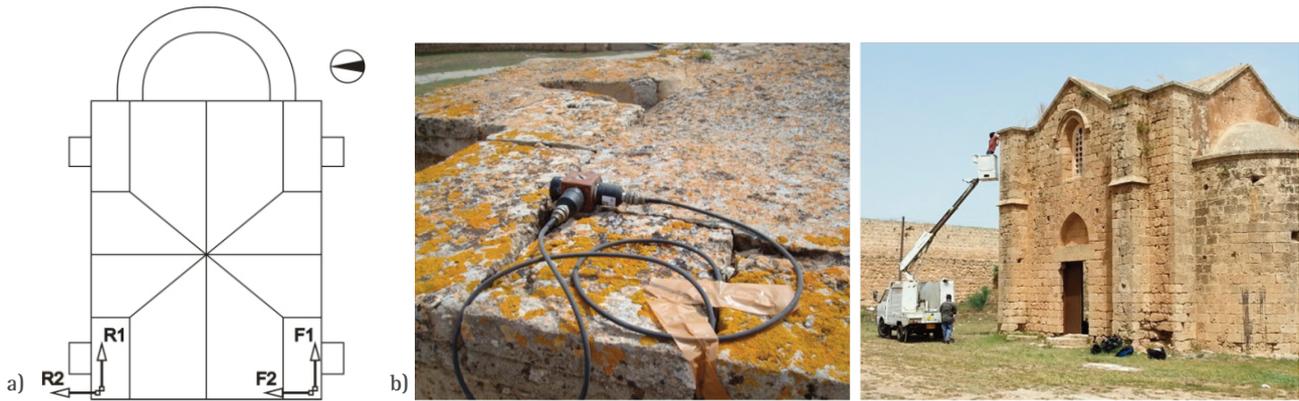
FIGURE 9. Dynamic identification. (a) One of the test setups showing the position of the reference (R) and free (F) accelerometers; and (b) views of the dynamic measurements.

some views of the dynamic measurements where the sensors were positioned with the aid of an elevating work platform. In total, the first six modes of vibration of the Church were identified. Table 1 presents the estimated frequencies and damping ratios of the six modes, as well as the standard deviation of these parameters.

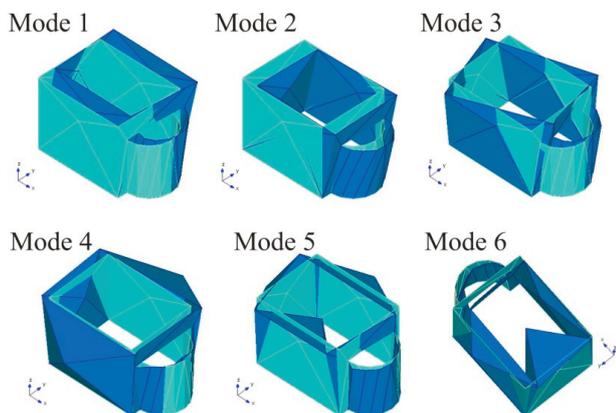
FIGURE 10. Experimental mode shape identified by means of the software ARTEMIS Modal Pro.

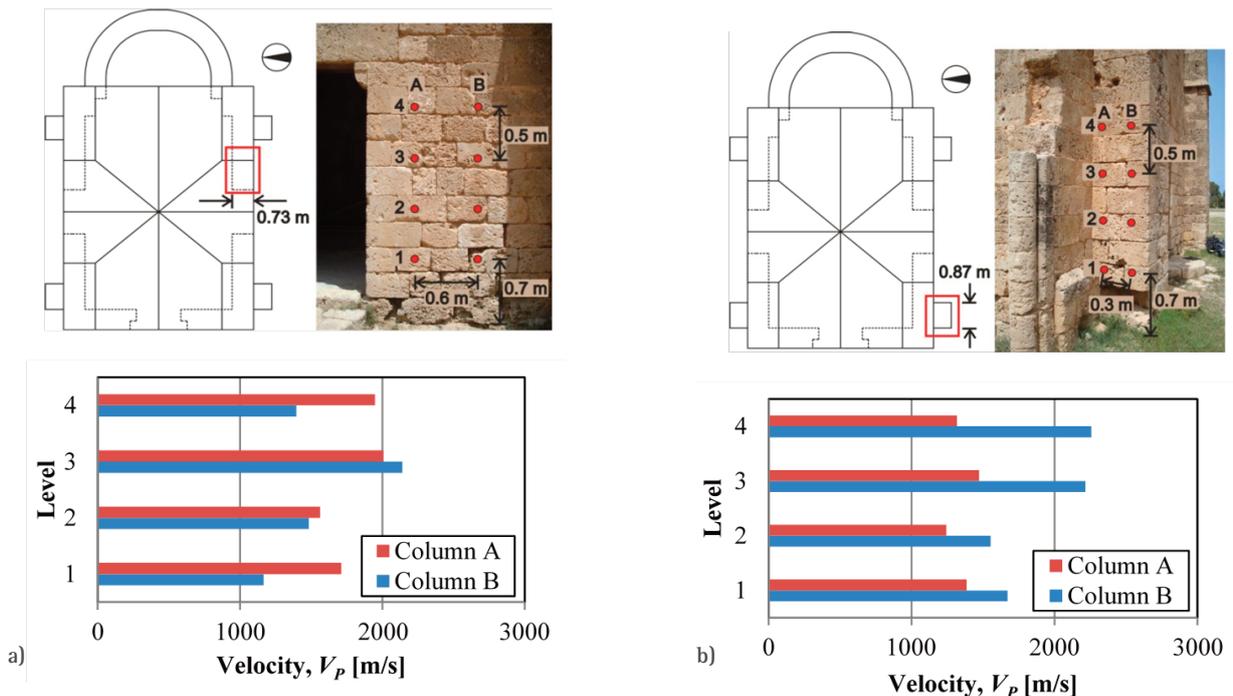
FIGURE 11. Direct testing locations, grids and measured velocities of the (a) south wall and (b) southwest buttress.

Direct testing was performed in two locations of the Church – the south wall and the southwest buttress. The purpose was to evaluate the masonry condition and, in particular, to assess the presence of internal voids, different materials or if repair works had occurred there. On each location, two vertical columns (A and B) and four horizontal levels were tested (4 pairs of points per column).

Regarding the south wall (Figure 11a), the sonic velocity ranged from 1170 to 2140 m/s and the average values in A and B were 1810 and 1550 m/s, respectively. In general, Column A presented higher values with low variation, indicating that the masonry around the entrance was probably rebuilt with new stone units in the past; while most of the stones located afar may still be the original ones in worse condition. Concerning the

buttress (Figure 11b), the sonic velocity ranged from 1240 to 2260 m/s and the average values in A and B were 1360 and 1920 m/s. The outer masonry layer (column B) showed a better condition than the internal section, indicating that the outer stone units might have also been replaced in the past or some weak filling / voids are present inside the buttress. In both tests, the coefficient of variation was lower than 10%.

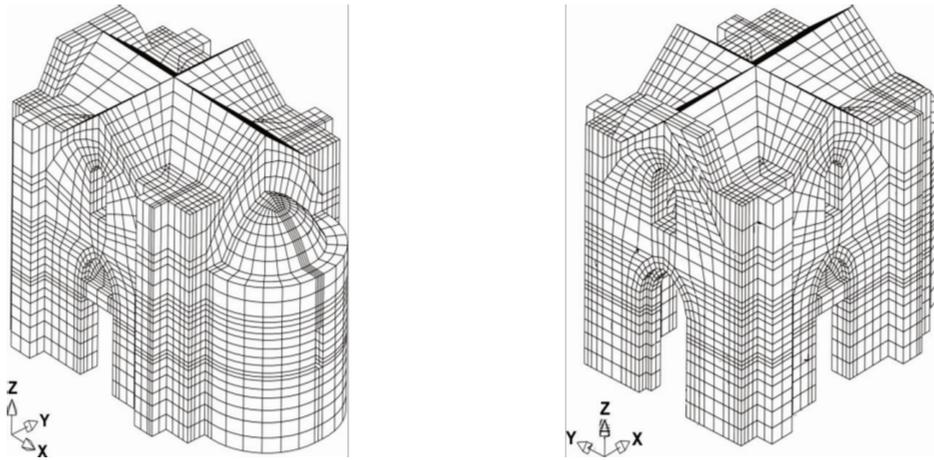
FIGURE 12. Views of the finite element mesh of the Church.

FEA BV, 2018] with the aid of geometrical data gathered from available laser scanning. A macro-modeling approach for masonry was adopted, and a tridimensional model was developed considering the relatively simple geometry of the Church. The generated finite element mesh, shown in Figure 12, is composed of two types of regular solid elements: twenty-node isoparametric solid brick elements and fifteen-node isoparametric solid wedge elements. This last type of element corresponds to less than 1% of the whole model. In total, the model is formed by 10,448 elements with 53,309 nodes and 159,927 degrees of freedom. Regarding the boundary conditions, all degrees of freedom of nodes at ground level ($Z = 0$) were restricted.

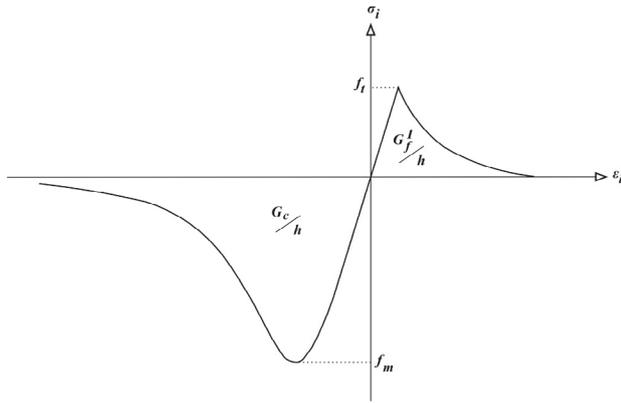
FIGURE 13. Adopted inelastic behavior of masonry (not drawn to scale).

Table 2 presents the physical and mechanical properties of masonry that were adopted based on literature [Lourenço, 2010] and on the previous study of another Famagusta building [Lourenço et al., 2012]. A relation $E = \alpha \cdot f_c$ was used, with α equal to 500. As noted by Lourenço et al. [2012], the parameter α is rather variable for masonry with values ranging from 200 to 1000. Moreover, the ductility index for compression was taken equal to 1.6 mm, which is a suggested value for a compressive strength lower than 12 N/mm². The ductility index for compression corresponds to the ratio G_c/f_c , which represents the fracture energy normalized by the compressive strength (f_c) [Chiaia et al., 1998], [Vasconcelos, 2005]. The masonry tensile strength and the tensile fracture energy were assumed equal to 0.2 N/mm² and 0.02 N/mm, respectively. These values describe a very low strength material, yielding finally a zero strength response.

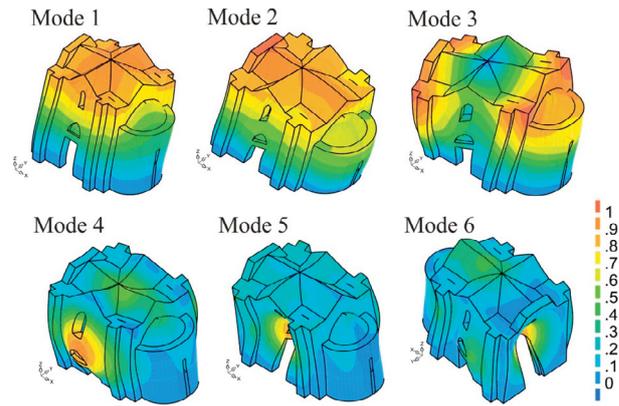
FIGURE 14. Numerical mode shape configurations (deformation scaled to a unitary value).

From Table 3, it can be seen that the maximum error is lower than 5% for all the modes, with an average error of 2.7%. Moreover, the MAC values emphasize a good consistency of the first four deflected configurations (average of 0.89). In particular, modes 1 and 2, which possess 73% and 76% of the total mass participation in the transversal (Y) and longitudinal (X) directions, respectively, presented a virtual flawless consistency. This outcome denotes a good agreement between the numerical and real geometrical features of the Church.

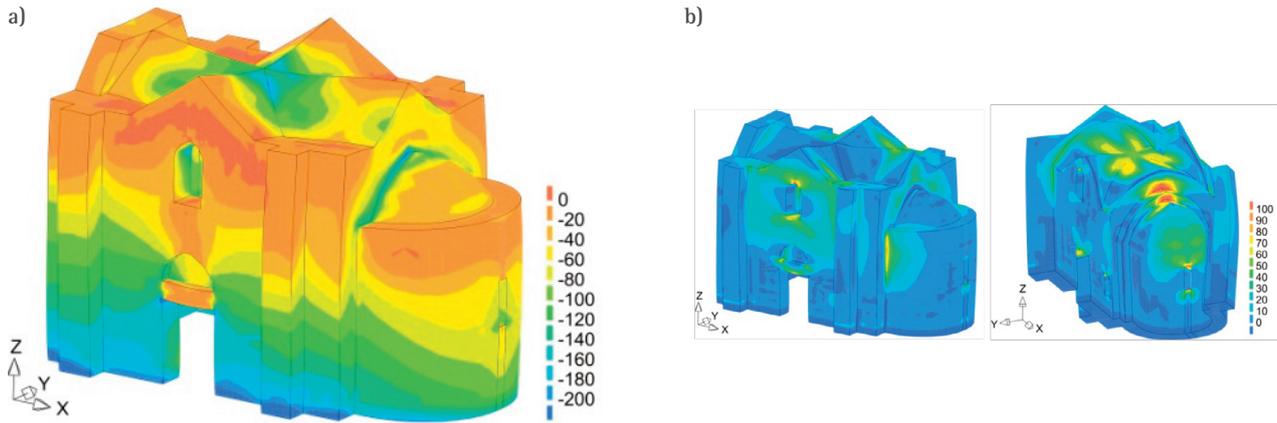
FIGURE 15. Deformed shape and distribution of (a) minimum (compressive) and (b) maximum (tensile) principal stresses, due to self-weight (in the last picture, the stresses are plotted on the internal surfaces of the vault and of north and east walls). Units: kPa.

The maximum tensile stress is 0.23 N/mm^2 , which is in the range of the adopted tensile strength, indicating incipient cracking.

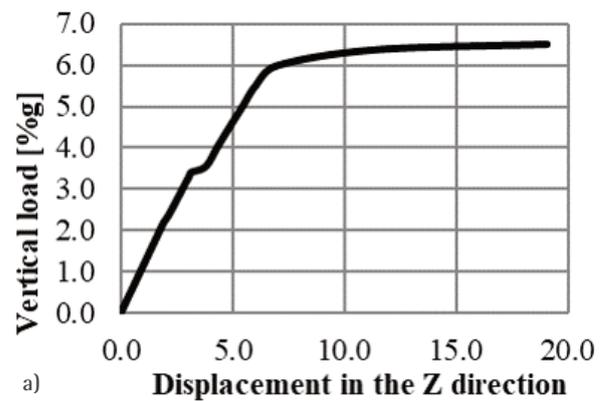
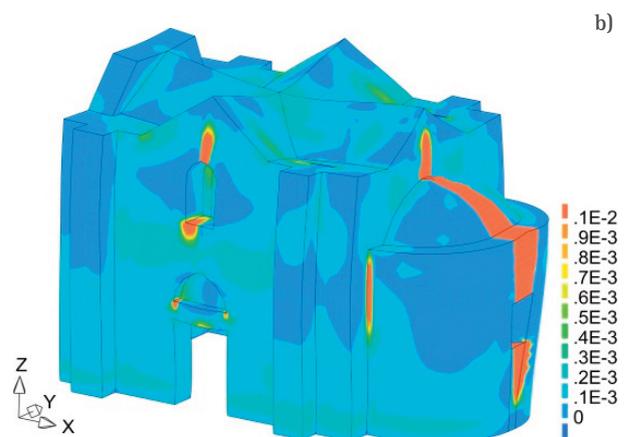
FIGURE 16. Capacity of the building against vertical loading. (a) force-vertical displacement diagram, plotted at the top of the apse (units: m); and (b) deformed shape and cracking, given by the maximum principal strain ϵ_1 , due to vertical loading, at maximum capacity.

failure. Figure 16a presents the force-vertical displacement diagram, indicating that the building was able to withstand approximately 6.5 times its own weight. An approximate linear behavior is observed until the structure reaches a ductile failure, which is corroborated by the final plateau of the curve. Note that the displacements were measured at the top of the internal double-arch, which was selected based on the response of the Church when subjected to its self-weight. In addition, Figure 16b shows the deformed shape and cracking of the building calculated at the beginning of the ductile behavior. Here, the cracking is measured by the maximum principal strain (ϵ_1), i.e. strain caused by pure tensile stresses. The failure mechanism of the Church corresponded to the localized failure of the apse side, whereas the rest of the structure shows an overall good condition, except for concentrated damage around the windows. These results indicate that the building presents a notable safety level in terms of vertical loading, which can be credited to the high stiffness, short spans and good load bearing capacity of the masonry walls in compression.

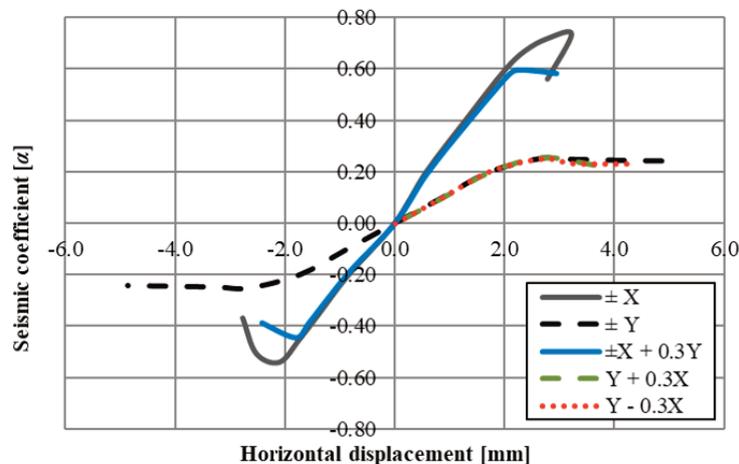
FIGURE 17. Mass-proportional pushover capacity curves.

From Figure 17, it is observed that the capacity of the Church is controlled by the transversal Y direction. The longitudinal X direction presents a better performance, which can be attributed to the sturdiness of the structure and the presence of the apse that limits the displacements. The failure mechanism of the structure in its transversal direction is characterized, to some ex-

tent, by a ductile behavior as demonstrated by the post-peak tendency of the capacity curves. Contrarily, in its longitudinal direction, the structure is characterized by a quasi-brittle behavior. According to these curves, the building can withstand a transversal static horizontal acceleration of $0.25g$, which coincides with the PGA prescribed by the code for rock, but seems insufficient for the local soil conditions. Below, a time history analysis is carried out for validation.

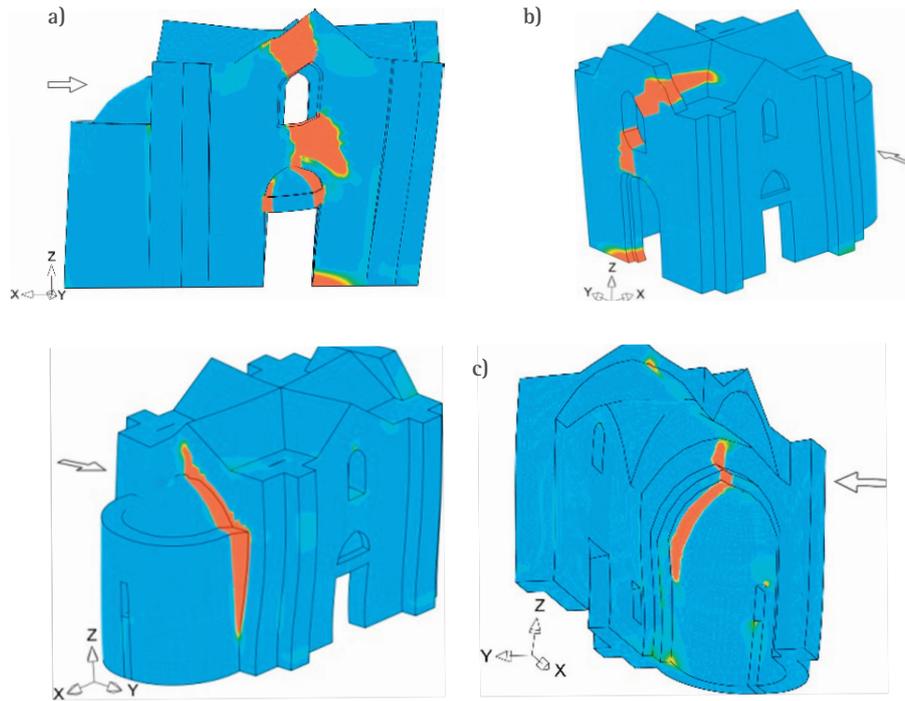
FIGURE 18. Deformed shape and cracking, given the maximum principal strain ϵ_1 , based on pushover analysis. The results correspond to the following loading patterns: (a) “(+X)+(0.3 Y)”, (b) “(-X)+(0.3 Y)”, and (c) “+Y”. The direction of the full mass-proportional load is given by the orientation of (the white arrows, while the shaded arrows show the direction of the combined 30% loading.

Additionally, Figure 18 shows the cracking patterns of the building, given by the maximum principal strain. These patterns correspond to the analyses with the lowest seismic coefficients in both X and Y directions, which were measured at the end of the capacity curves, at failure. Damage is mainly concentrated between openings, which is a typical failure feature of masonry buildings; and is also present on the apse side and at the base; particularly at the corners of the entrances.

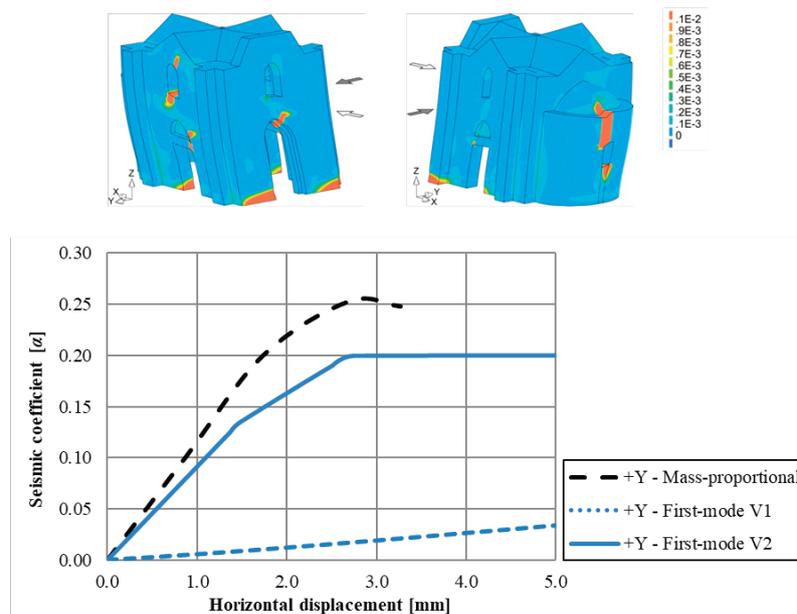
FIGURE 19. Comparison of capacity curves obtained with pushover proportional to first-mode “V1” and “V2” (blue color), with respect to the mass-proportional pushover capacity curve (black color) in the +Y direction.

Figure 19 compares the resulted capacity curves measured through pushover proportional to first-mode “V1” and “V2”, with respect to the mass-proportional capacity curve in the +Y direction previously obtained (See Section 5.2). As observed in this graph, the capacity curve proportional to first-mode “V1” presents a totally different stiffness compared to the others.

This approach was certainly not able to correctly reflect the mass-distribution of the building, changing the contribution of mode 1. Contrarily, the capacity curve proportional to first-mode “V2” presents a good approximation with respect to the mass-proportional approach. In this case, the maximum static horizontal force that the building can support is reduced by approximately 20%. Additionally, the resulting deformed shape and damage pattern is similar to the one obtained from the mass-proportional approach and, therefore, it is not repeated (see Figure 18c).

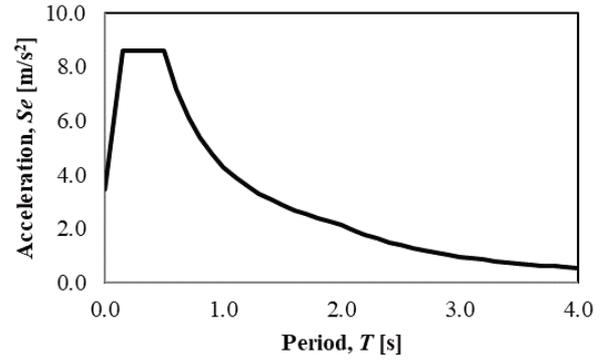
FIGURE 20. Elastic response spectrum for Famagusta based on a damping ratio of 5% and a ground type “D”.

damping ratio ξ of 5% and a ground type “D”, according to the geological characteristics of Famagusta [Safkan, 2012]. The peak ground acceleration (PGA) is equal to 3.4 m/s², corresponding to the design ground acceleration on rock, affected by the ground factor. Additionally, Figure 21 presents the artificial accelerograms, which were generated by means of the software SIMQKE_GR [Gelfi, 2006] with a baseline correction filter using SeismoSignal [Seismosoft, 2018]. The total time of the seismic action was set equal to 20 s, including a duration of 10 s for the stationary part of the seismic action.

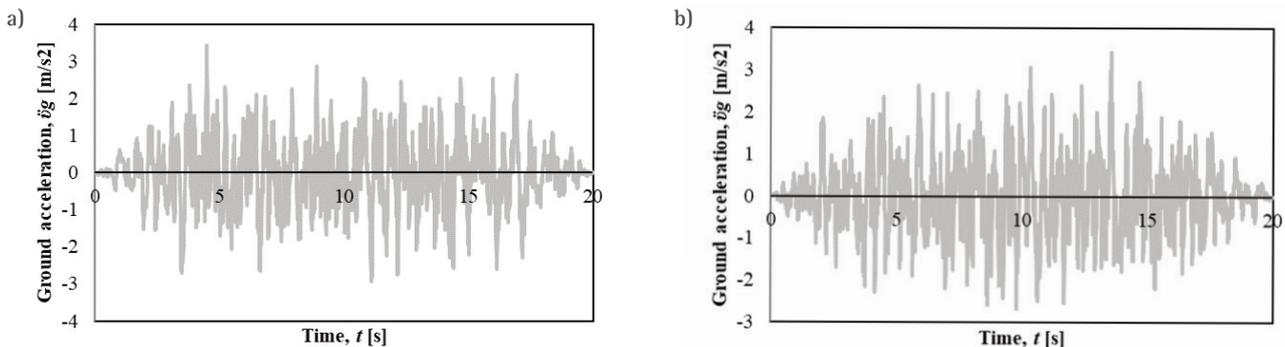
FIGURE 21. Unscaled time-history of accelerations with a PGA of 3.4 m/s², applied in the (a) X and (b) Y directions.

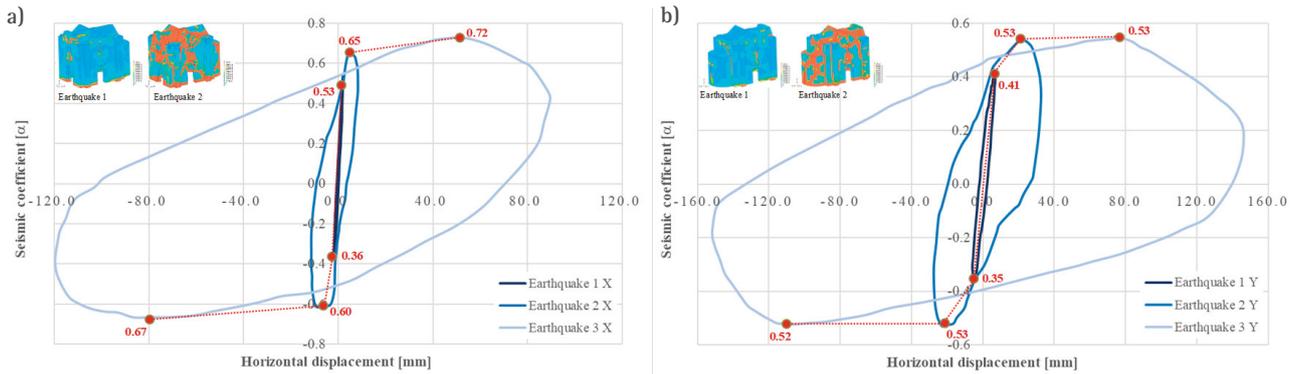
FIGURE 22. Envelopes of the relation between the horizontal displacement, measured at the top of the building, and the seismic coefficient: (a) in the longitudinal direction (X); (b) in transversal direction (Y). $PGA_1 = 3.4 \text{ m/s}^2$; $PGA_2 = 6.8 \text{ m/s}^2$; $PGA_3 = 13.6 \text{ m/s}^2$.

Figure 22 presents the envelopes of the hysteric behavior of the church in both directions and for the three earthquakes. Similarly to the pushover results, the horizontal displacement of the structure is based on the average displacement measured at the four top corners of the building. The maximum seismic coefficients (Earth-

The red line represents the equivalent capacity curve obtained from the dynamic analysis, based on the maximum force. In the Y direction, the structure presents high deformations for the Earthquake 3 and reached its load capacity for the Earthquake 2, indicating that the structure can collapse for a PGA lower than 13.6 m/s^2 . Thus, the damage obtained for the Earthquake 3 can be not realist and it is not presented.

Figure 22 presents principal tensile strains (indicator of the damage) for the Earthquakes 1 and 2, in which is observed that the Church presents severe damage after the Earthquake 2 with generalized cracks over the entire structure. In the Earthquake 3, an extreme input was applied, aiming at reaching the full collapse of the structure. Thus, the Church presents very high deformations, which can be not realist and the structure collapse for a lower PGA and deformation. Thus, the principal tensile strains for the Earthquake 3 are not presented. It is noted that the damage pattern was obtained by scanning the maximum values of the tensile principal strain ϵ_1 through all the time-steps of the earthquake, because while performing time-history analyses, the generated cracks of the building pass through cycles of opening, closing and reopening along the different time-steps.

Comparing the results of the mass-proportional pushover and time-history analysis, several differences can be observed. Figure 22 demonstrates that the Earthquake 3 is associated to an extreme input, which was used mainly to reach the maximum load capacity and the full collapse of the building. Thus, the Church presents very high deformations for this earthquake and significant different from the results obtained from the pushover analyses (Figure 17), indicating that they can be unrealistic and the structure can collapse for a lower PGA ($< 13.6 \text{ m/s}^2$). Besides the deformation, the maximum seismic coefficient obtained from the pushover analysis in the most vulnerable direction (Y direction) (0.25) is significantly lower than the capacity obtained from the dynamic analysis (0.53) (difference of about 50%). These differences can be attributed to the fact that: (a) the pushover analysis was only able to simulate the local failure of some elements of the Church, while the time-history analysis captured the global structural collapse; (b) the pushover analysis does not include the contribution of the higher modes; and (c) the pushover analysis was developed mainly for regular structures (in-elevation and in-plan) and with rigid diaphragms. It is noted that the pushover analysis with load pattern proportional to the first mode provides an even lower capacity (0.20 g). However, the maximum seismic coefficient obtained from the pushover analysis (0.74 and 0.67 in the positive and negative direction, respectively) and the dynamic analysis (0.72 and 0.67 in the positive and negative direction, respectively) in the longitudinal

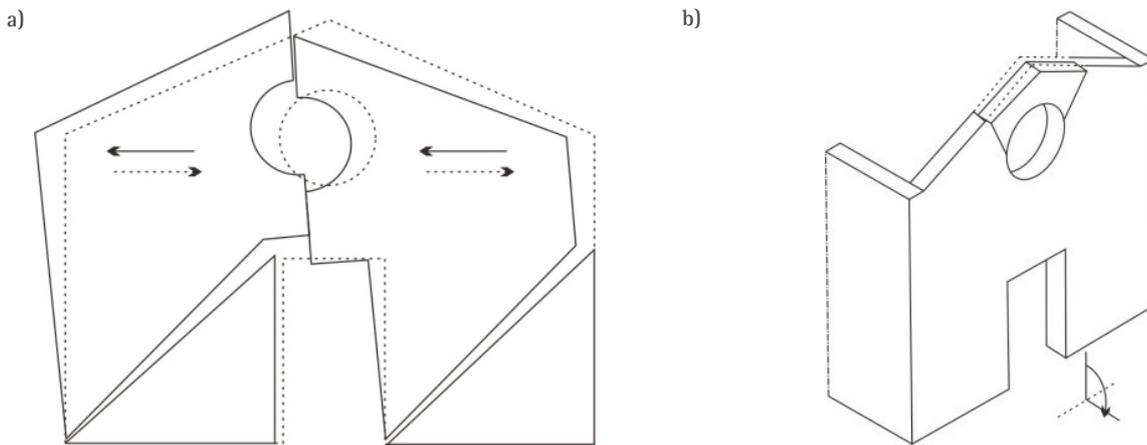
FIGURE 23. Typical seismic failure mechanisms of churches according to the Damage Abacus [NIKER, 2010]. In-plane shear failure mechanism of (a) the whole façade or (b) of the top section of the window.
