ANNALS OF GEOPHYSICS

SPECIAL ISSUE: LESSONS FROM THE PAST: THE EVOLUTION OF SEISMIC PROTECTION TECHNIQUES IN THE HISTORY OF BUILDING

PREFACE

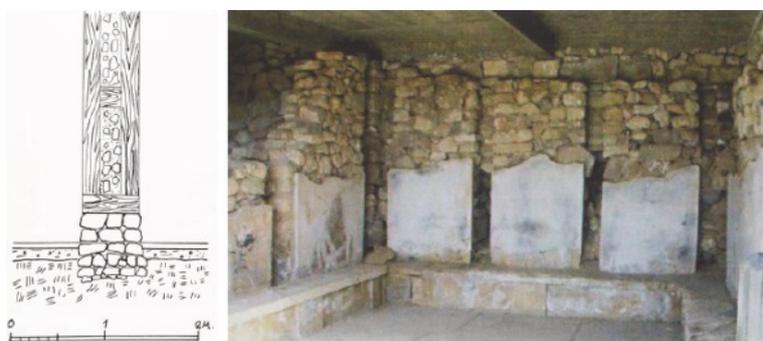
FIGURE 1. On the left reconstruction of a wall in Tyllissos with stone socle, timber frame and rubble filled interior [Shaw, 1971]; on the right timber traces in the Hagia Triada villa [Tsakanika and Theohari, 2009].

archaeological sites and structures. Three main lines can be identified. The first is the historical analysis and includes five papers, the second the evaluation of the historical construction and monuments with six papers, and the last paper is about the trends for the future. The paper by Alberti [2019] introduces this special issue, reminding that earthquakes were a well-known phenomenon in antiquity, which inspire myths and require the creation of apotropaic cults. In Aegean Bronze Age architecture, a series of anti-seismic practices were early developed. In Minoan palaces in particular, lighter walls were superimposed on stone ones built at basement or ground floor levels. Using vertical, horizontal and cross timbers they put up wooden frames into which stone and mudbrick elements were integrated and bonded, and over which clay and plaster were later applied (Figure 1). The paper investigates how extensively these techniques are spread in the Mediterranean basin and elsewhere, both in ancient and modern times, and how they can be applied to contemporary architecture in a more sustainable way.

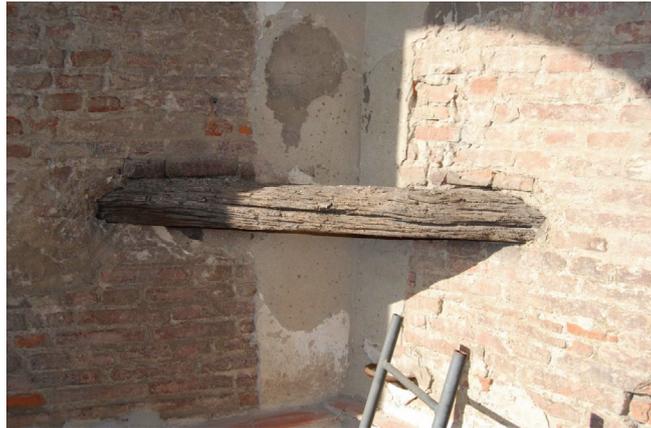
FIGURE 3. Wooden chain inserted in an internal corner of the belfry of the Church of San Lorenzo in Borgo San Lorenzo (FI).

The contribution of Arrighetti and Minutoli [2019] outlines a methodological program designed with the purpose of offering an innovative and multidisciplinary analysis of seismic protection techniques in historical architecture of Mugello, a medium-high risk seismic area between Tuscany and Emilia Romagna. This analysis can allow the breaking up and dating of the single construction and destruction actions present in a building, leading to the identification of some uncommon elements in respect to traditional construction techniques, being able to interpret a specific function (Figure 3).

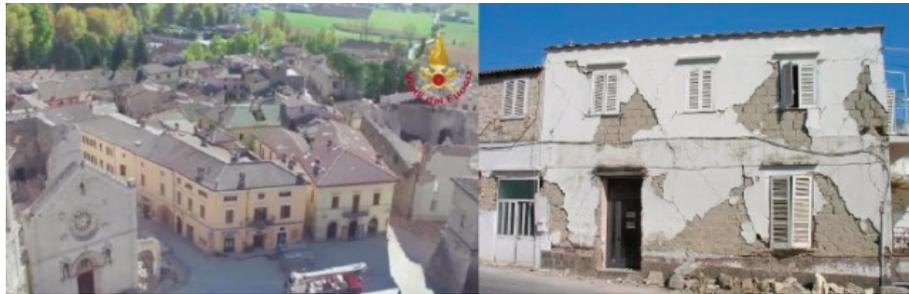
FIGURE 5. Example of damage occurring in: a) Norcia, after the 2016 earthquake and b) Ischia, after the 2017 earthquake.

Codes are a fundamental part of the overall strategy for the reduction of seismic risk. Marotta et al. [2019] gave a historical analysis of the seismic codes after the 1859 Norcia (Central Italy) and 1883 Ischia (Southern Italy) earthquakes, both of them a remarkable attempt to improve the performance of ordinary unreinforced masonry structures by regulating architectural configuration and structural details (Figure 5).

Both documents represent a codification of earthquake-resistant techniques used in seismic zones in accordance with best practice, still extraordinarily relevant when compared with both recent standard recommendations about structural details and with the performance observed during the 2016 and 2017 earthquakes.

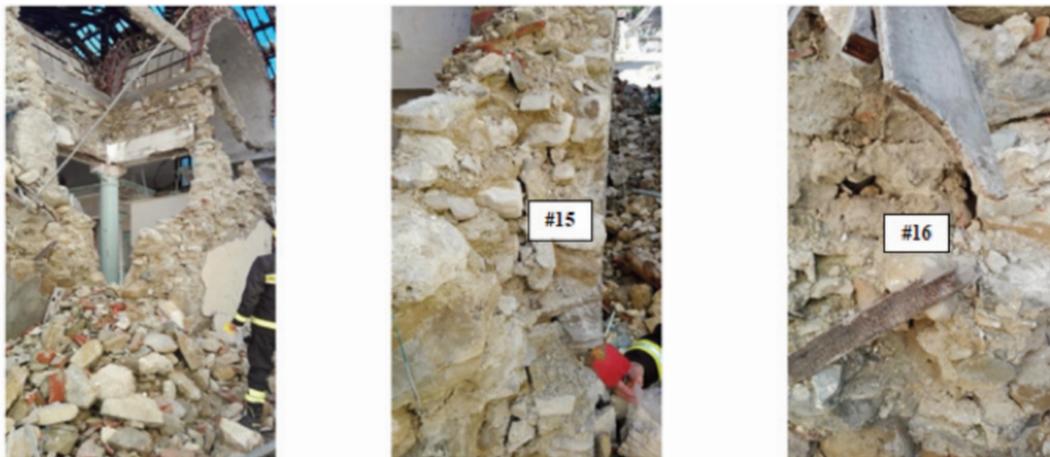
FIGURE 8. Mortar sampling campaign in Pretare – St. Rocco Church (Arquata del Tronto).

Mirabile Gattia et al. [2019] analysed the historical masonry mortar from sites damaged during the Central Italy 2016-2017 seismic sequence, with particular reference to the village of Arquata del Tronto. It is well known that the mortar quality is a fundamental parameter that influence the structural behavior of masonry, especially under seismic actions (Figure 8). The authors carried out both diagnostic techniques and mechanical test, in order to correlate the obtained values with the performance of the original masonry. The results of the analysis could be useful as support for future research, supplying information for establishing priorities of intervention for repairing, consolidation and reconstruction activities. The experimental and numerical investigations on the seismic response of the San Frediano Bell tower in Lucca (Figure 9) is the subject of the paper by Azzara et al. [2019]. During a monitoring campaign for about one year, many seismic events were recorded. The most relevant turned out to be the Amatrice earthquake, which struck Central Italy on August 24th, 2016. A review of the experimental results obtained has first been shown.

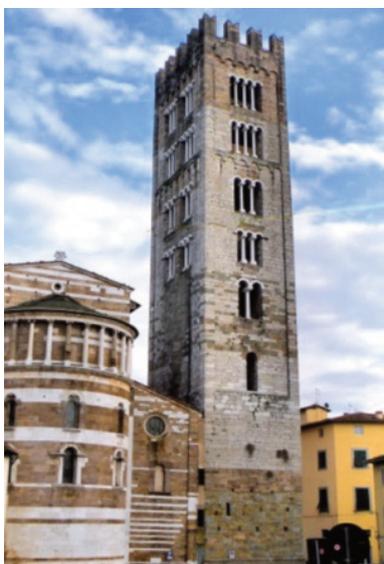
FIGURE 9. The San Frediano Bell Tower in Lucca.

Then, a finite element numerical model of the tower has been presented and validated via model updating, by assuming the hypothesis of no tensile strength for the material. The experimental records of the Amatrice earthquake have been also included and a numerical simulation of the tower subjected to the Lunigiana earthquake, recorded at Fivizzano (Tuscany) on June 21st, 2013, has been performed. The results pointed out the sensitivity of the tower to seismic actions.

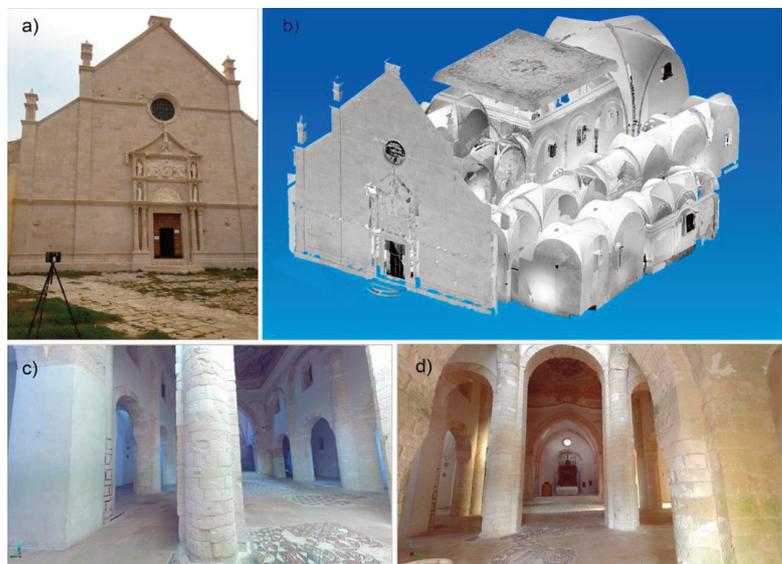
FIGURE 10. Laser scanner Focus 3D MS120 (FARO) (a), mesh visualization of the model (b), RGB visualization of the cloud points (c, d).

Cozzolino et al. [2019] present the results of the surveys carried out on the Abbey of Santa Maria a Mare at San Nicola (Tremeti Islands, Italy, Figure 10), a monument in a significant state of degradation. In order to define the restoration interventions, the structure has been analysed through the realization of 3D metric surveys (photogrammetry and laser scanner) and non-invasive geophysical surveys (Ground Penetrating Radar Technique). The use of non-destructive testing techniques allowed a proper representation of the conservation status of the abbey, which constitutes a key element of knowledge in order to guarantee the success of a restoration project, the valorisation and the fruition of the monument itself.
