# The role of remote sensing to enlarge knowledge on health state of a historical building hit by earthquake: the case of Garisenda leaning tower (Bologna)

Arianna Pesci<sup>\*1</sup>, Giordano Teza<sup>2</sup>, Fabiana Loddo<sup>1</sup>, Alessandra Rossetti<sup>1</sup>,  
Ilaria Gambuzzi<sup>3</sup>, Augusto Gambuzzi<sup>3</sup>

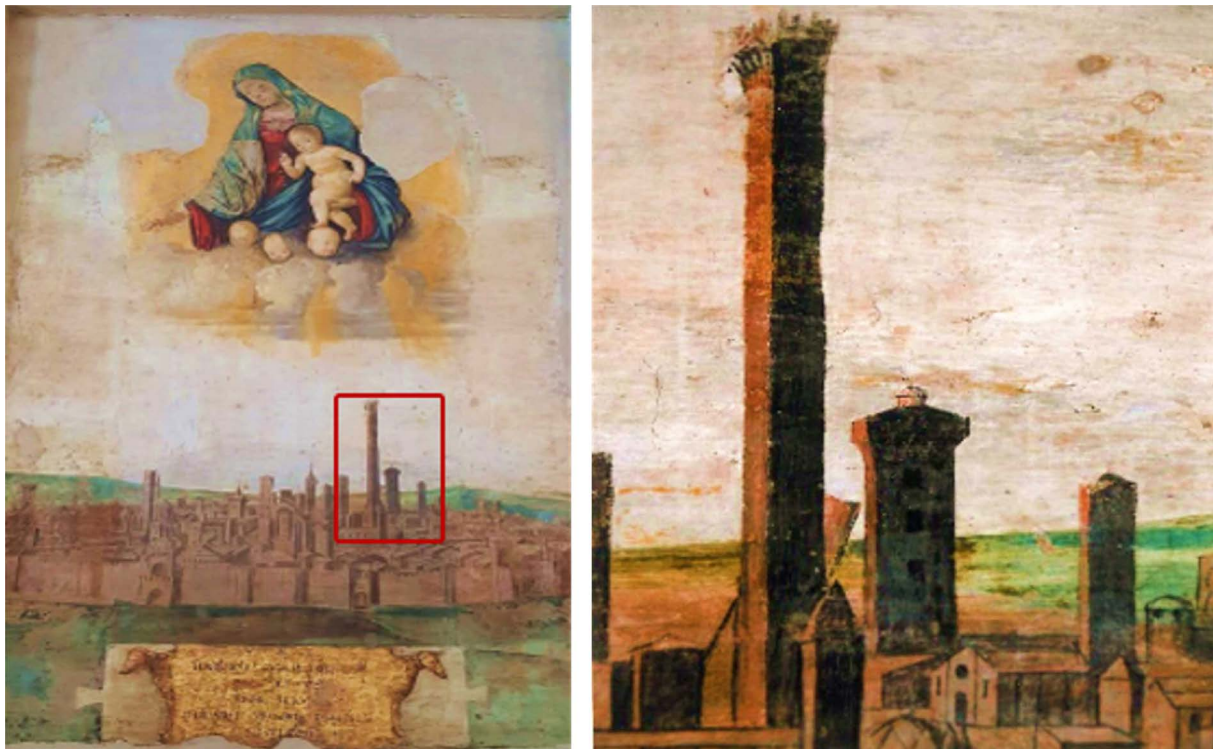
**Figure 3.** The fresco “Madonna del Terremoto”, commissioned to obtain pardon and stop earthquakes in 1505: (a) general view; (b) particular where the highest Asinelli tower and the very leaning Garisenda tower (partially hidden by the Asinelli one) can be seen. The other towers shown here do not longer exist.

Even if it was not the most devastating earthquake to hit Bologna, the “infinite swarm” is very well remembered in the chronicles of the time because the main shocks continued for a long time, from December 24, 1504 to May 19, 1505 (Guidoboni and Ciuccarelli, 2003), with Mercalli-Conconi-Sieberg (MCS) intensity VI-VII. A reasonable estimate of the median of the distribution of Peak Ground Acceleration (PGA) related to this seismic sequence is  $PGA \sim 0,17g$  (Baraccani et al., 2017), where  $g$  indicate the gravitational acceleration ( $g = 9.81 \text{ m/s}^2$ ). For comparison, the median PGA reached in the case of the two most important phenomena that have affected Bologna in the last 1000 y, occurred in 1365 and 1433, was  $PGA \sim 0,23g$ . In any case, duration and damage inherent to the “infinite swarm” led Giovanni II Bentivoglio, lord of Bologna, to commission a fresco depicting the “Madonna del Terremoto” (“Mother Mary protecting the city from the earthquake”) as a symbol of devotion and auspice of protection. This fresco highlights the steep slope of the Garisenda in 1505 (Fig. 3), whose severe inclination is cited in several

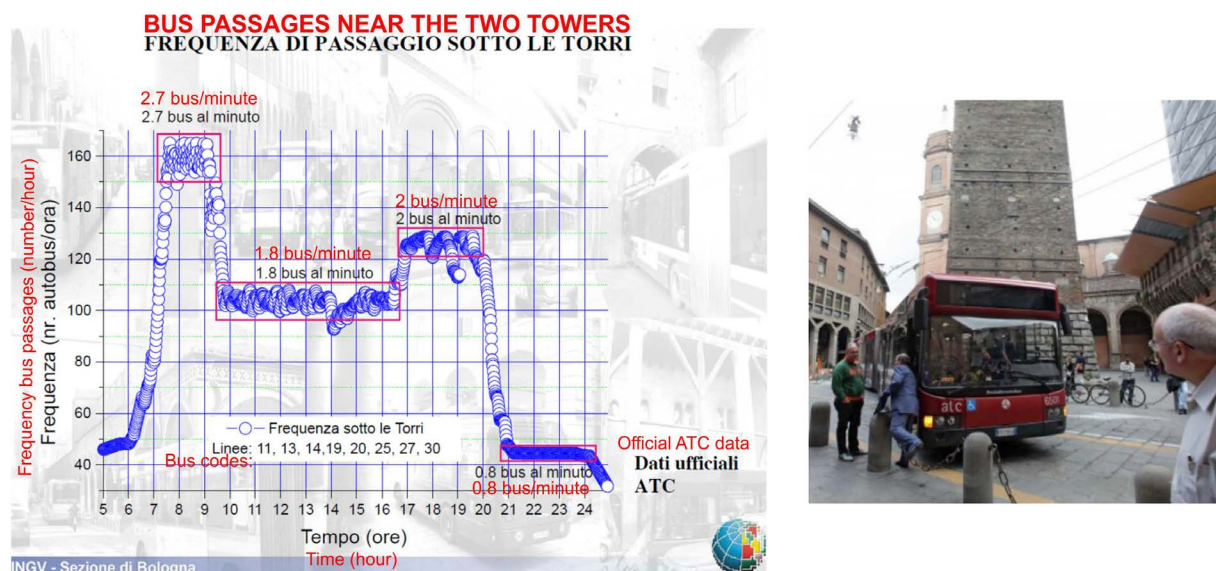
**Figure 4.** Frequency of buses passage close to Two Towers in 2011 (data from the official timetable of the Bolognese urban mobility company). Until the autumn of 2023, the road traffic, including trucks and buses, passed within a few meters from the towers. Today, because of concerns on Garisenda safety, road traffic passes near to Asinelli tower, but not close to Garisenda.

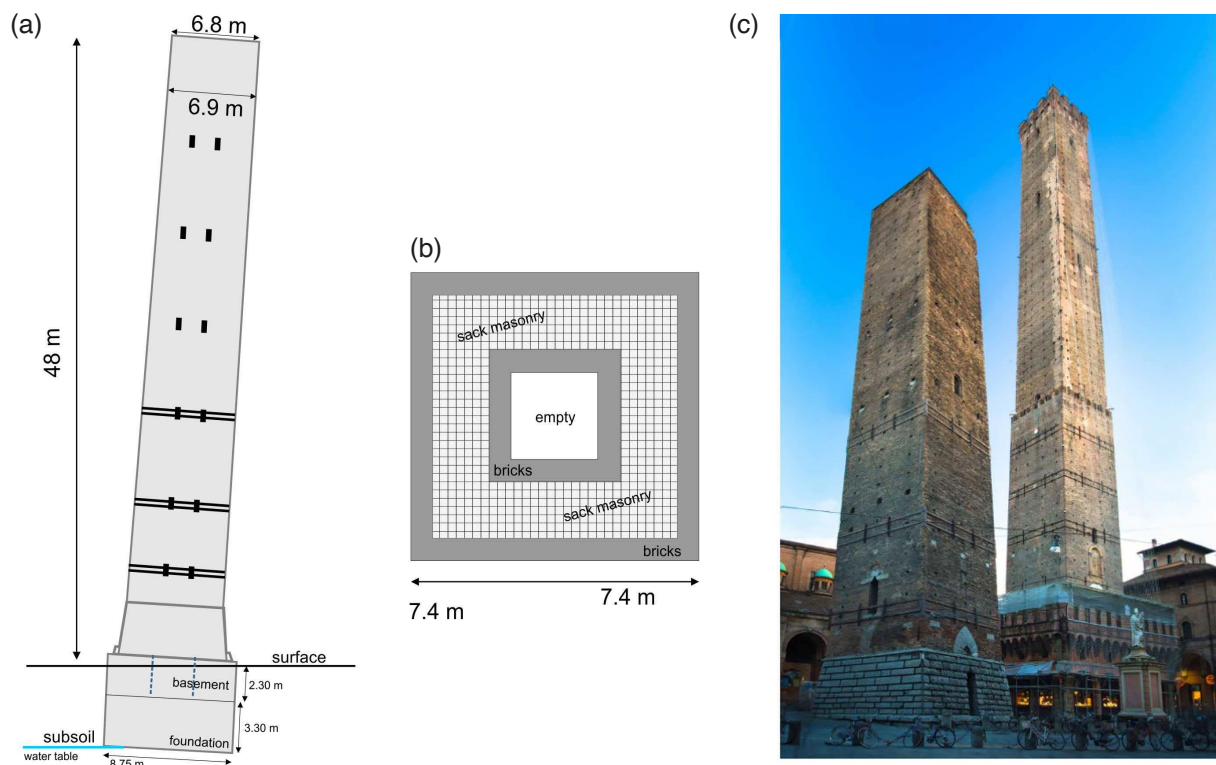
**Figure 5.** (a) Scheme of Garisenda and its basement/foundation, where main tower geometry, tapering, chains and tie rods at various levels are shown; (b) typical horizontal cross-section with rubble masonry; (c) image of Garisenda (left) and Asinelli tower (right).

direction, i.e. east (E), north (N), west (W) and south (S) respectively. According to Fabbi (2011) and Bertolini (2023), the main characteristics of the Garisenda tower are (Fig. 5): 1) since 1890, after the demolition of the buildings around the base (shops and chapel), it is an isolated structure on all sides; 2) the height of the tower is 53.5 m above the foundation level and 48.2 m above ground; 3) its center of gravity is approximately 25 m above the foundation plane; 4) the tower weighs approximately 42 MN and has a square plan, with a side of 7.4 m at the base; 5) the current inclination angles of the straight tower axis are  $3.91^\circ$  towards E and  $0.67^\circ$  towards S. For comparison, the mean leaning angle of Torre di Pisa after the 1993 and 2001 remediation works is  $3.97^\circ$  (Burland et al., 2020); 6) the tower basement and foundation have an 8.75 m wide squared base. The external walls of the basement, which are made of selenite blocks, reach 2.3 m below ground level whereas the foundation block is a 3.3 m high massive conglomerate parallelepiped (the space between the basement external walls is filled with the same material). The foundation footing, which is orthogonal to the tower straight axis, reaches  $\sim 5.6$  m below the surface level and, therefore, is lapped by the mean water table. The structure of basement and foundation was obtained by means of coring and ground penetrating radar inspections.

The tower was built of bricks with the rubble masonry technique, “muratura a sacco” in Italian, similarly to the Asinelli Tower. Its cross-section is squared and tapered from bottom to top, from 7.4 m side at the base to about 6.9 m. The base of the Garisenda, restored at the end of the 19<sup>th</sup> century, is made up of squared blocks of selenite, superimposed on each other. Between 1998 and 2000 the body of the tower was renovated and consolidated using internally metal frames at various levels (up to the top) anchored to the walls with joints designed for a strong hold. Subsequently, three external bands, steel belts with sealing angles on the corners of the tower, were also installed up to a height of 25 m (Giordano, 2000; Giordano and Nanelli, 1999).

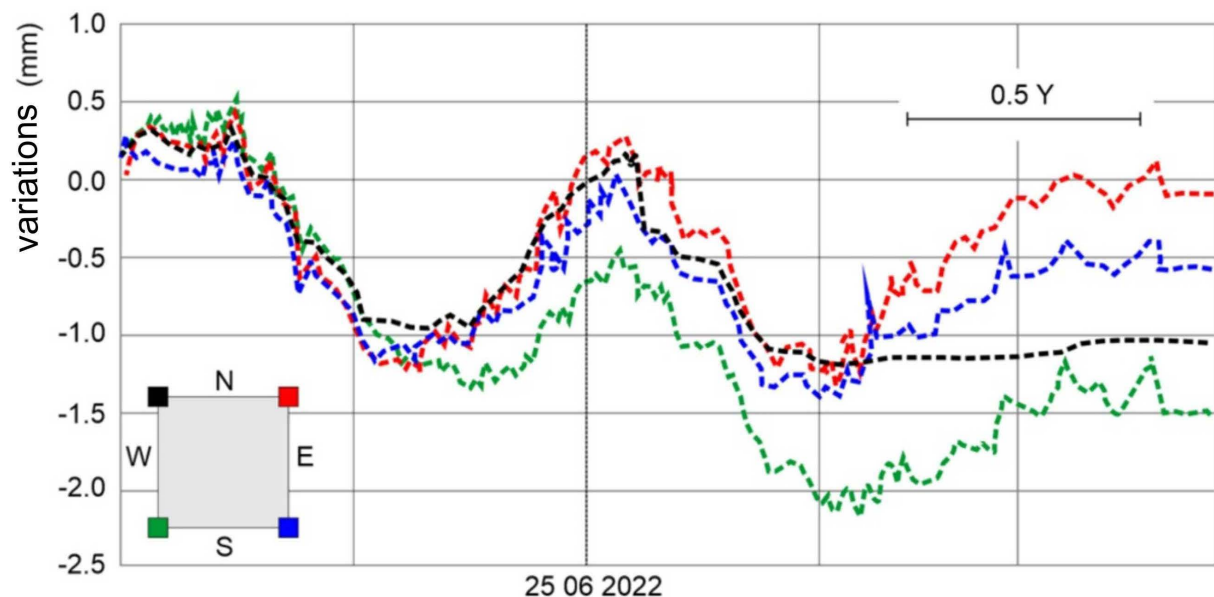
**Figure 7.** Time series related to strain gauges placed in the corners of Garisenda base. The green line (SW corner) shows, besides oscillations, a  $\sim 1$  mm/y drift. The image results from a digitalization of the original graph shown in Aiello et al. (2023).

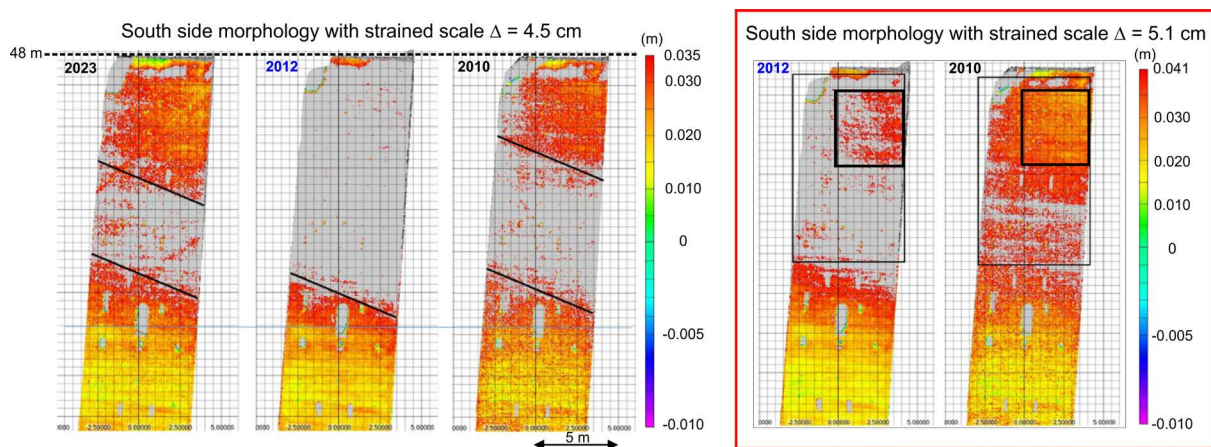
Figure 11. S side. More maps with 4.5 cm and 5.1 cm difference ranges to visualize the distributions of differences for tower elevation higher than 25 m.

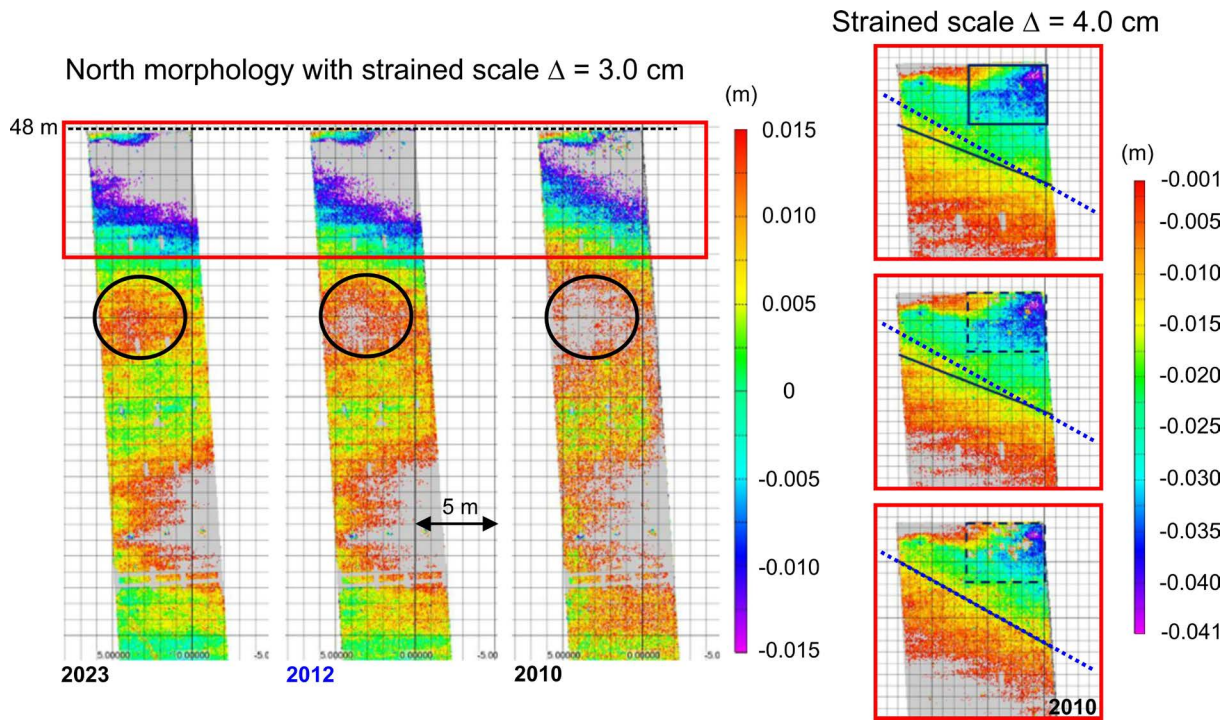
Figure 12. N side. More maps (4.0 cm and 3.0 cm ranges) to visualize the distributions of differences in the body and in the upper part of the tower (elevation higher than 15 m).

The N side (Figs. 10b and 12) was affected by significant deformations after the 2012 shock. The positive pattern of 2010 was reduced both in the 15-25 m band and in the upper 30-40 m band. Furthermore, a negative widening of the apical band can be observed above 40 m, with a more accentuated twisted shape that suggests a twist. The 2023 measurements showed attenuated variation compared to 2012, confirming the morphology although highlighting a slight decrease in values, continuous compared to the previous phenomenon. In this case, the values suggest that the structure of the elevation was slightly more recessed than in 2010. It seems that deformations affected the façade portion above 30 m.

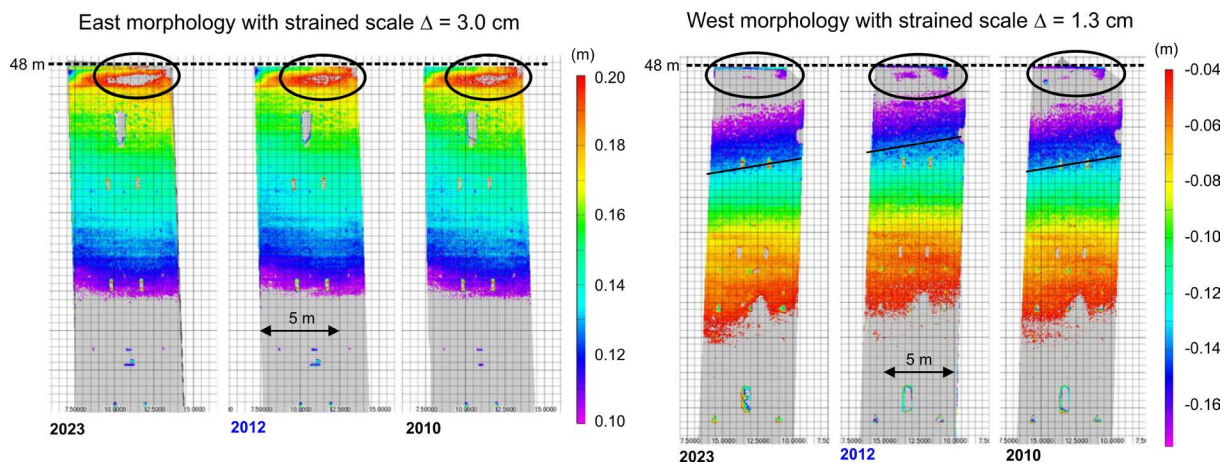
Figure 13. More maps to observe minor variations on façades E (left panel, difference range: 3.0 cm) and W (right panel, difference range 1.3 cm) above 20 m elevation.

The E side (Figs. 10c and 13, left panel) seems to be much more stable, even if a positive accentuation of the apical band can be observed in an extremely contained area. Above 45 m, an advance on the normal of the plane is clearly visible but the line marking the change in behavior is ~42 m high.

Finally, the W side (Figs. 10d and 13, right panel), in analogy with the E one, shows small differences observed at the limit of the resolution, with zero-positive values in the 12-22 m range and a slight indentation in the apical area above 40 m elevation.
