“ THE CONTRIBUTION OF INDIRECT TOPOGRAPHIC SURVEYS (PHOTOGRAMMETRY AND LASER SCANNER) AND GPR INVESTIGATIONS IN THE STUDY OF THE VULNERABILITY OF THE ABBEY OF SANTA MARIA A MARE, TREMITI ISLANDS (ITALY). ”

Marilena Cozzolino^{*,1}, Andrea Di Meo², Vincenzo Gentile²,

⁽¹⁾ Institute for Technologies Applied to Cultural Heritage, National Council of Researches, Via Salaria Km. 29,300, Monterotondo St. (Rome), Italia, ww.itabc.cnr.it

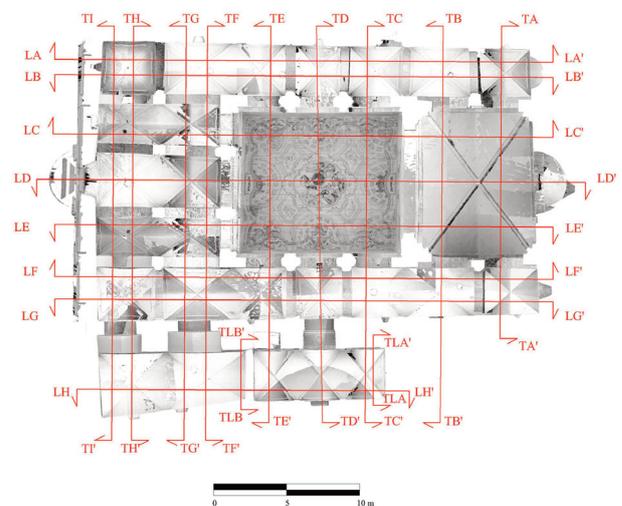
FIGURE 4. Location of the sections extrapolated by the point cloud.

external facade made up of approximately 18 million points was created. Figure 3 shows a three-dimensional view of the product of the point cloud conversion in meshes and some images obtained from the colorimetric overlay operation (RGB). The dot cloud was used to extract plants and sections in DXF format for vector data and TIFF for photographic data. Figure 4 displays the location of 11 cross sections and 8 longitudinal sections with respect to the main body of the building.
