## APPENDIX TO

# REMOTE SENSING, ARCHAEOLOGY AND HISTORICAL RECORDS: LOOKING FOR 1624 EARTHQUAKE TRACES IN SAN GIORGIO PARISH CHURCH OF ARGENTA (ITALY)

## Appendix A. The San Giorgio parish church in Argenta

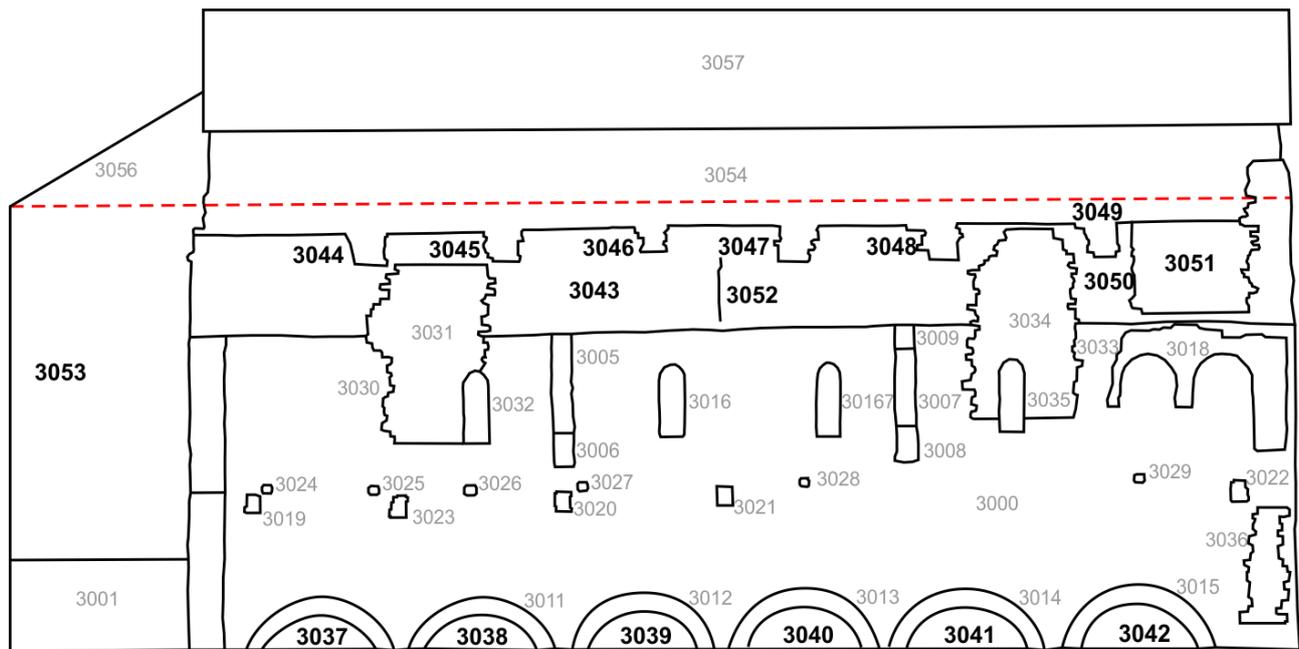
**Figure A1.** Stratigraphy of the wall, from Brunetti [1992] and drawn with the same nomenclature for stratigraphic units. The bold labels indicate the time span within which the 1624 earthquake occurred.

The stratigraphic analysis of the N side of the church performed by Brunetti [1992] provides information about the church architecture. This side is particularly suitable for that kind of analysis being close to the excavated areas and in a good state of conservation. The stratigraphic units (SUs) in which earthquake traces could be recognized are shown in Figure A1, which is modified from Brunetti [1992]. Most SUs date back to 1571, the year in which the church was restored, the arches were infilled (SU 3037-3042) and the apse was raised up (SU 3053). The SU 3043 indicates the elevation of the church parietal walls, while the SUs between 3044 and 3049 correspond to the holes for a new roof anchorage. The SU 3050 indicates a truncation and SU 3051 its subsequent infill (possibly due to the removal of the Virgin image). Finally, SU 3052 is a jamb.

The absence of SUs related to restoration works of the N side of the church is surprising, because the geophysical analysis shown in Brunetti [1992] indicates that the earthquake effects were quite strong and also liquefactions occurred. The lack of written sources about church damages or documents concerning restoration is also surprising. On the other hand, even today no cracks or fissures can be noticed. However, it should be noted that the 1773 restoration might have hidden these evidences, which could be caught by a means of a deeper inspection. It should also be underlined that extensive and continuous deformation on a large scale does not necessarily cause well visible cracks or fissures but indicates a phenomenon that significantly affected the monument. In some cases, morphological analysis applied to historical buildings struck by 2012 Emilia Romagna earthquake showed patterns compatible with the deformations expected in the event of an earthquake even in the absence of discontinuities on the walls of the monument. If an architectural element can be deformed, there are not necessarily extensive and/or localized cracks.
